Dealing with Heritage

Assessment and Conservation

Barbara Lubelli
Uta Potgiesser
Wido Quist
Susanne Rexroth

TU Delft OPEN
Publishing

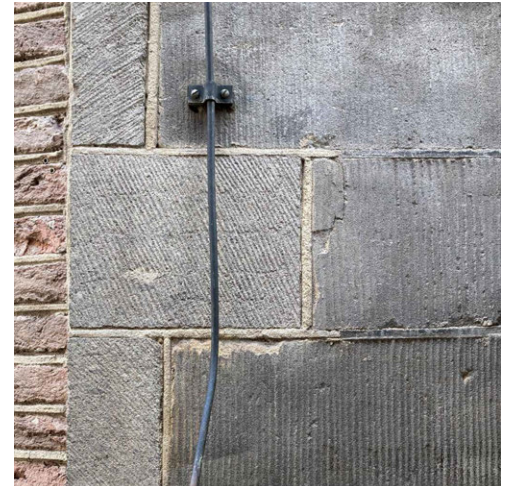
FIG. 2.7 Peperino Duro (left) used to replace Bentheim sandstone (right) in the Nieuwe Kerk in Amsterdam / Photo: W.J. Quist

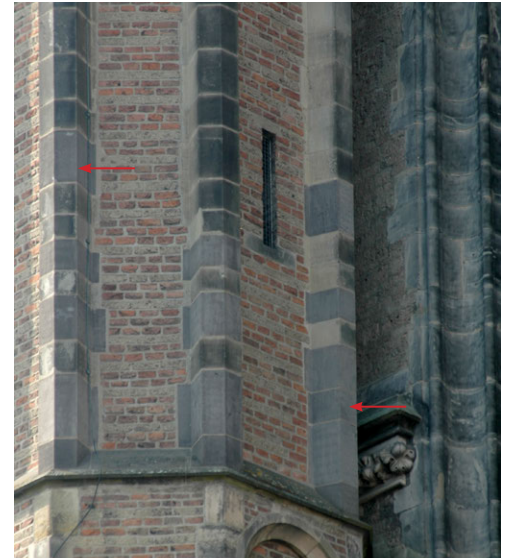
FIG. 2.9 Volvic basalt on the stair tower of the south transept of the Dom Church in Utrecht, as a replacement for Bentheim sandstone / Photo: W.J. Quist

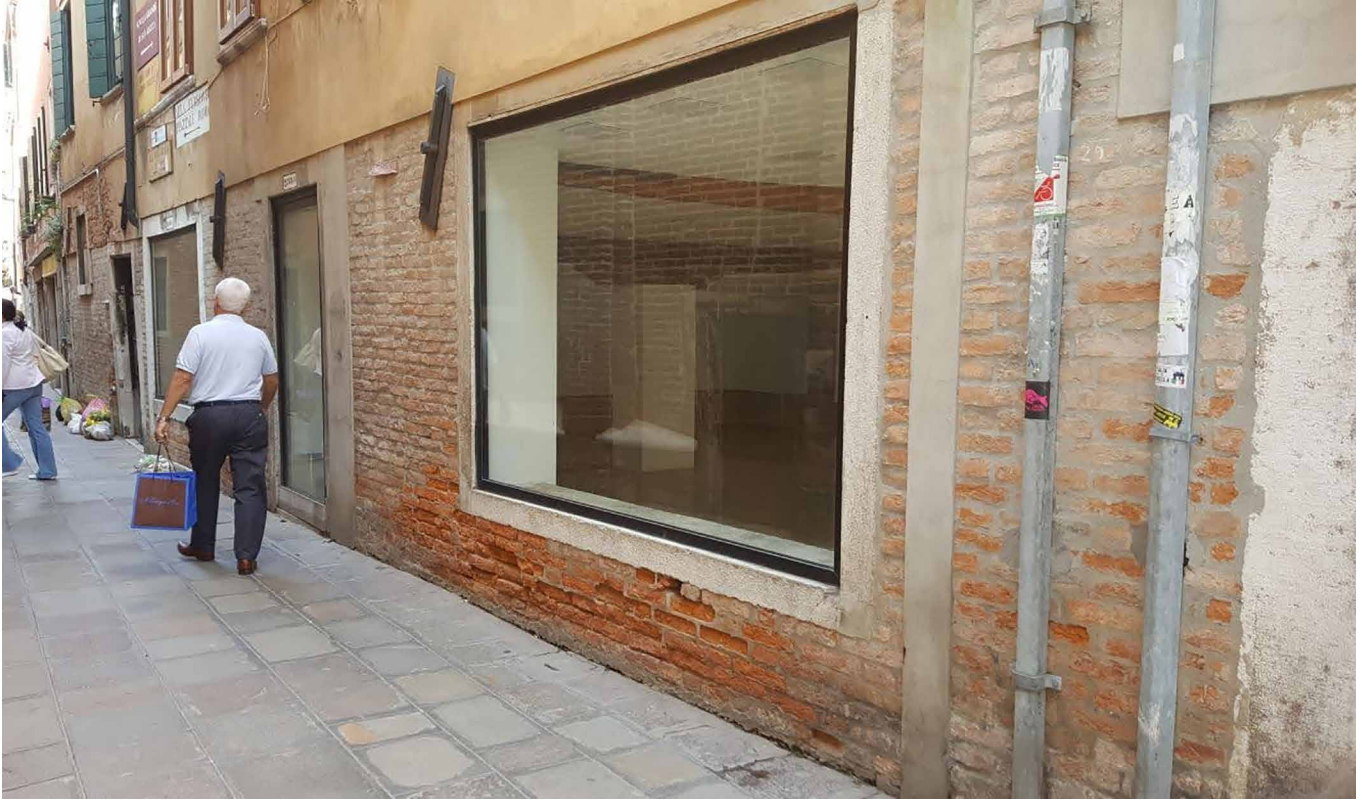
FIG. 3.1 Salt crystallization damage due to the presence of salts and rising damp, Venice, Italy / Photo: B. Lubelli

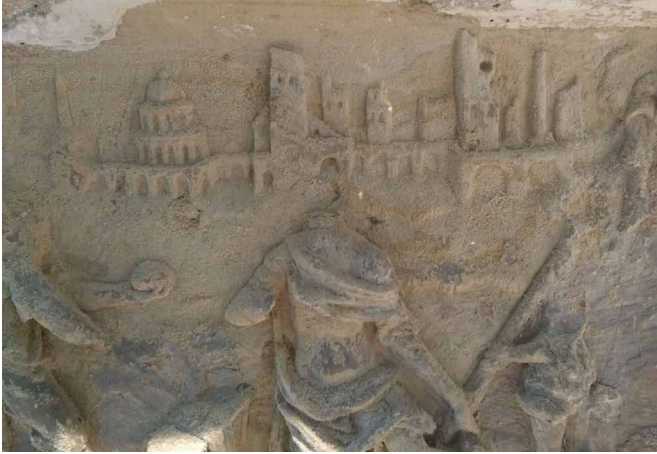
FIG. 4.4 Powdering of the stone: a consolidation treatment may be effective in this case / Photo: B. Lubelli

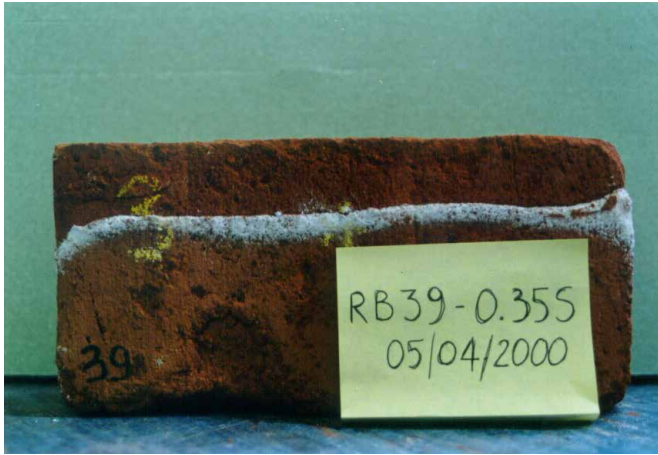
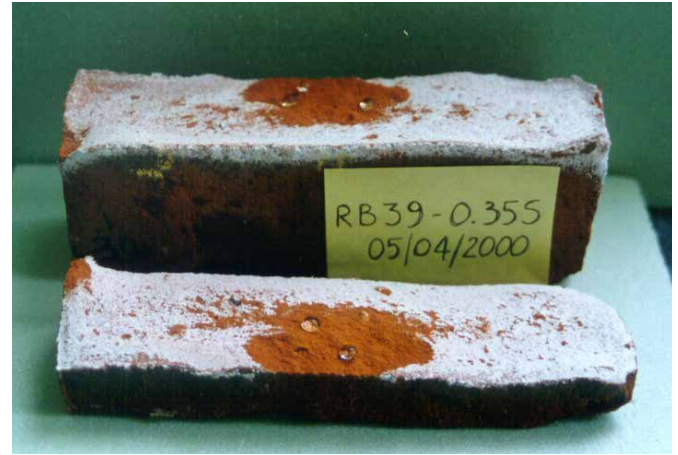
FIGS. 4.12/4.13 Salt accumulation beneath the layer treated with a water repellent (left) and subsequent spalling of the treated part (right) during a laboratory test / Photos: B. Lubelli

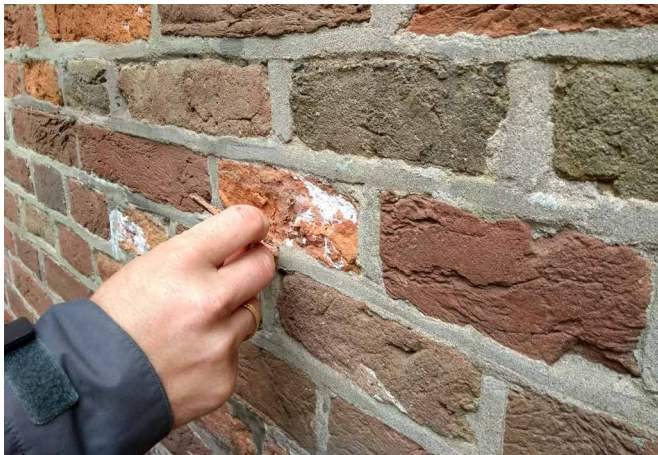
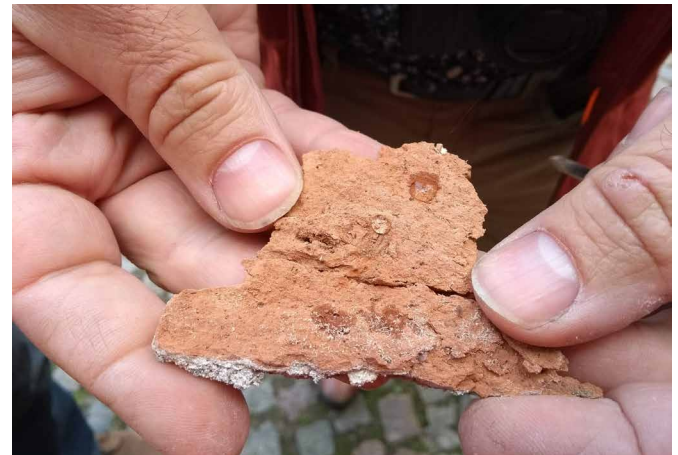
FIGS. 4.14/4.15 Spalling due to salt accumulation beneath the treated layer; the water repellent is still effective several years after the application / Photos: M. van Hunen

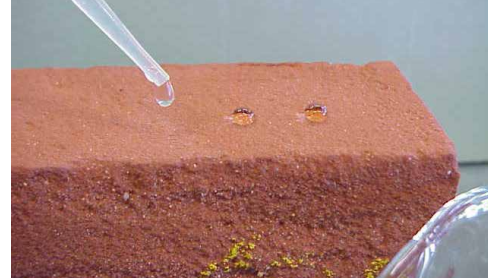
FIG. 4.19 Method for the assessment of effectiveness of water repellent treatment: beading effect / Photo: B. Lubelli

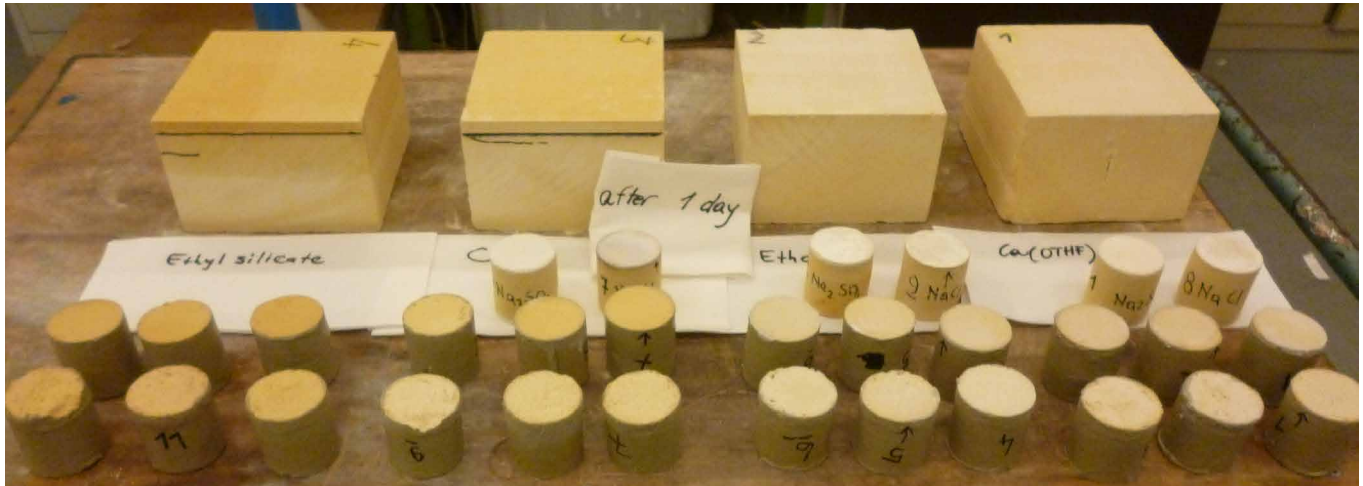
FIG. 4.23 Maastricht limestone 1 day after the application of different consolidation products: product 2 and to a lesser degree product 1, have caused whitening of the surface / Photo: B. Lubelli

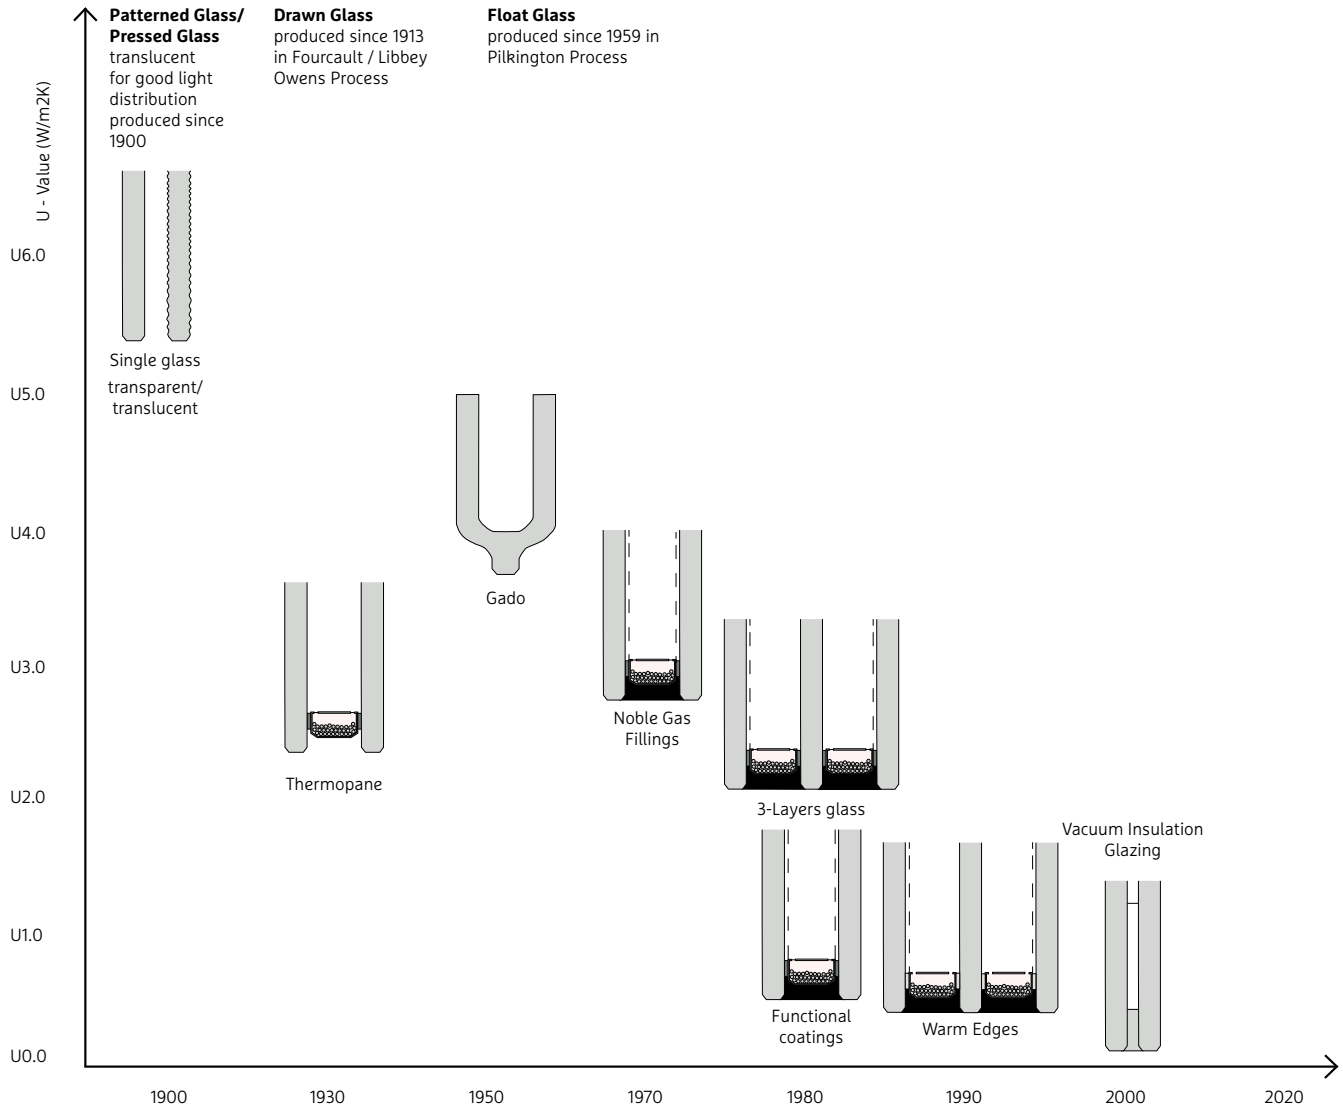
FIG. 5.13 Timeline of modern glass and glazing developments since 1900

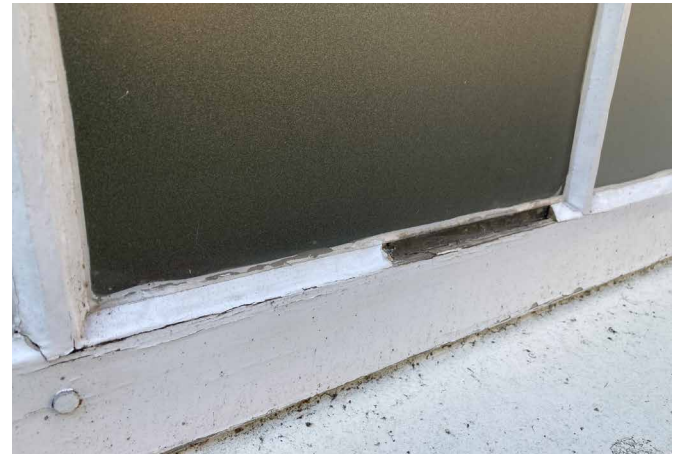
FIG. 5.18 Putty in wooden windowframe (in need of repair) / Photo: W. J. Quist

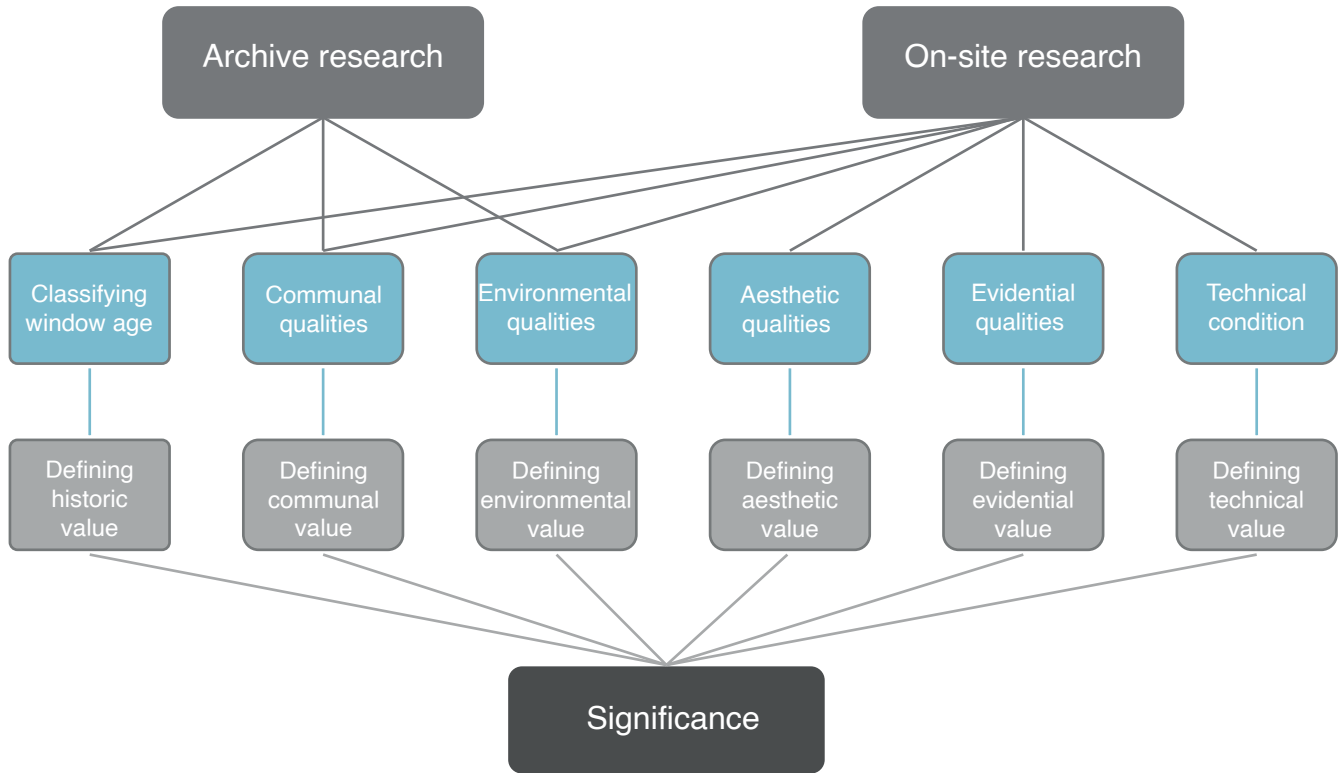
FIG. 5.23 A systematic significance assessment of historic windows includes archival and on-site research, the building context and all window components: frame, fittings, glazing, colour layers, shutters

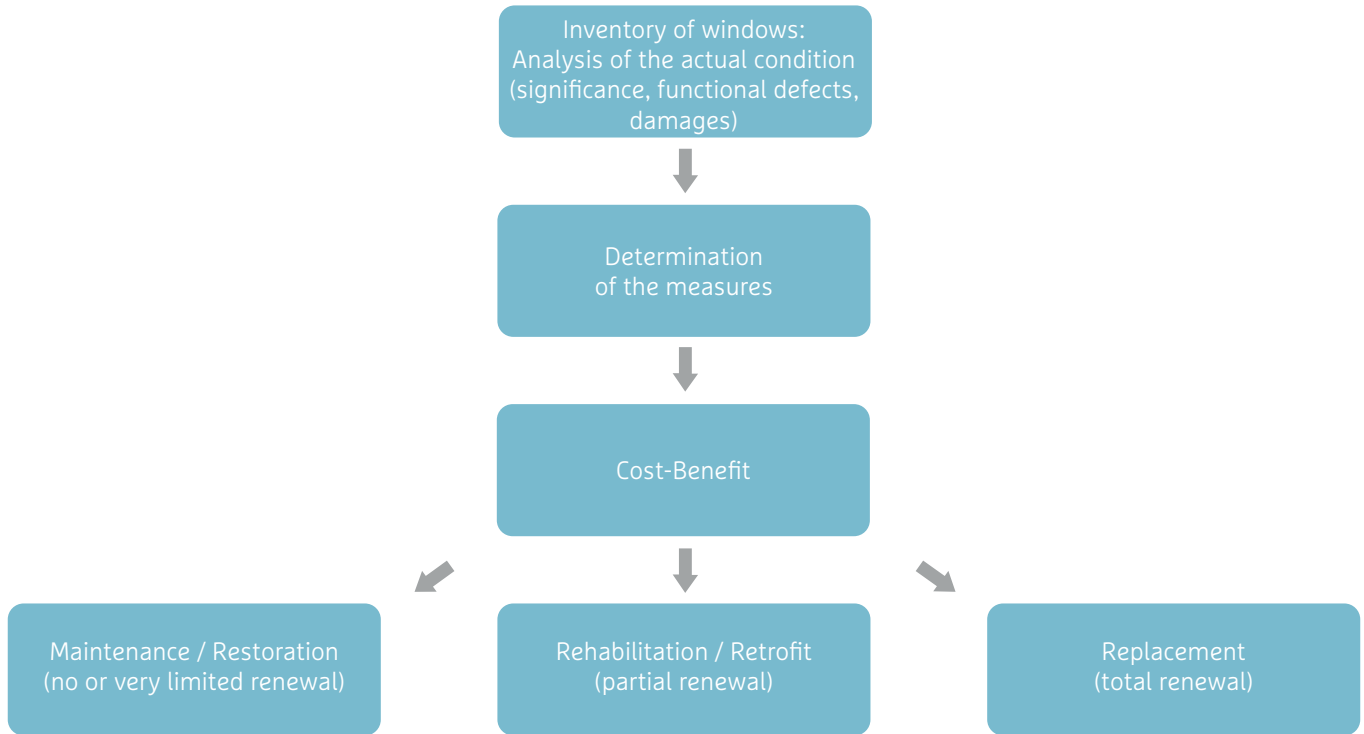
FIG. 5.24 Decision making between intervention categories for a single window

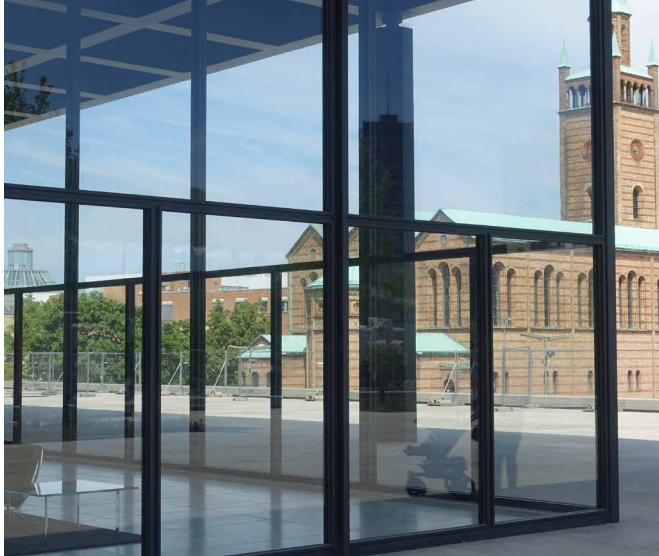
FIG. 5.39 New National Gallery, Berlin: original glazing (above) and three variants for the rehabilitation. In order to avoid glass breakage in the future, a double-thick laminated safety glass (2 x 12 mm) was used (second variant from above). The other two variants would have distorted the appearance of the construction too much. / Photo: F. May

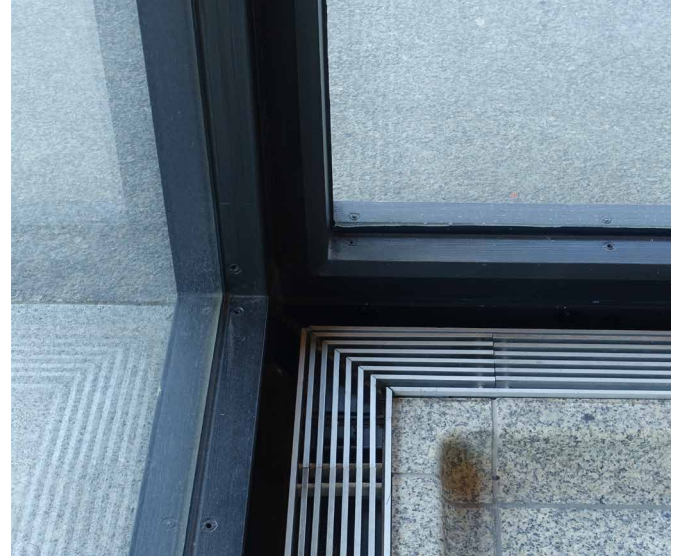
FIG. 5.40 New National Gallery, Berlin: New facade with a single glazing in a thermally non-separated construction / Photo: F. May
