# Durable past – sustainable future

Rob van Hees  
Silvia Naldini  
Job Roos

TU Delft OPEN  
Publishing

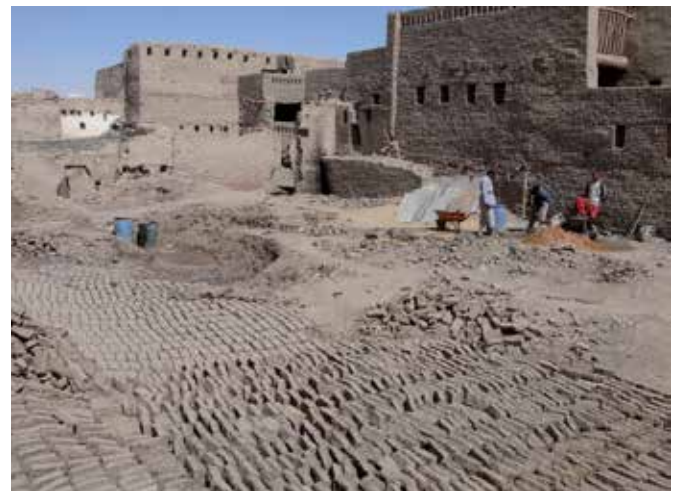
FIG. 2.1 Fabrication of brick, Qasr in Daklah (Egypt) / photo: D. Schultz

To make adobe brick, sand, clay, straw and often animal excrements are mixed. After mixing, either the material is shaped by hand to form bricks (adobe bricks or green bricks) or moulds can be used. The resulting bricks are baked in the sun [FIG. 2.1].

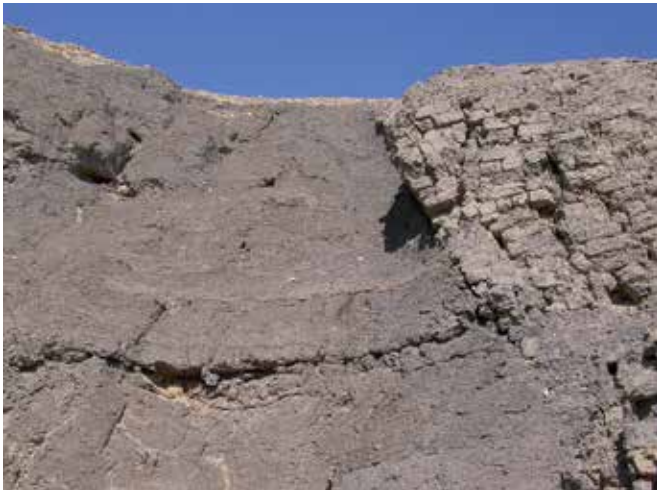
FIG. 2.3 Mastaba, Meidum, adobe (Egypt), detail / photo: D. Schulz

Depending on the local environmental conditions adobe may even show a considerable service life, as is the case of the mastabas, the tombs of the Egyptian kings, from the times before the Old Kingdom; many of them are surviving after thousands of years [FIG. 2.2, FIG. 2.3].

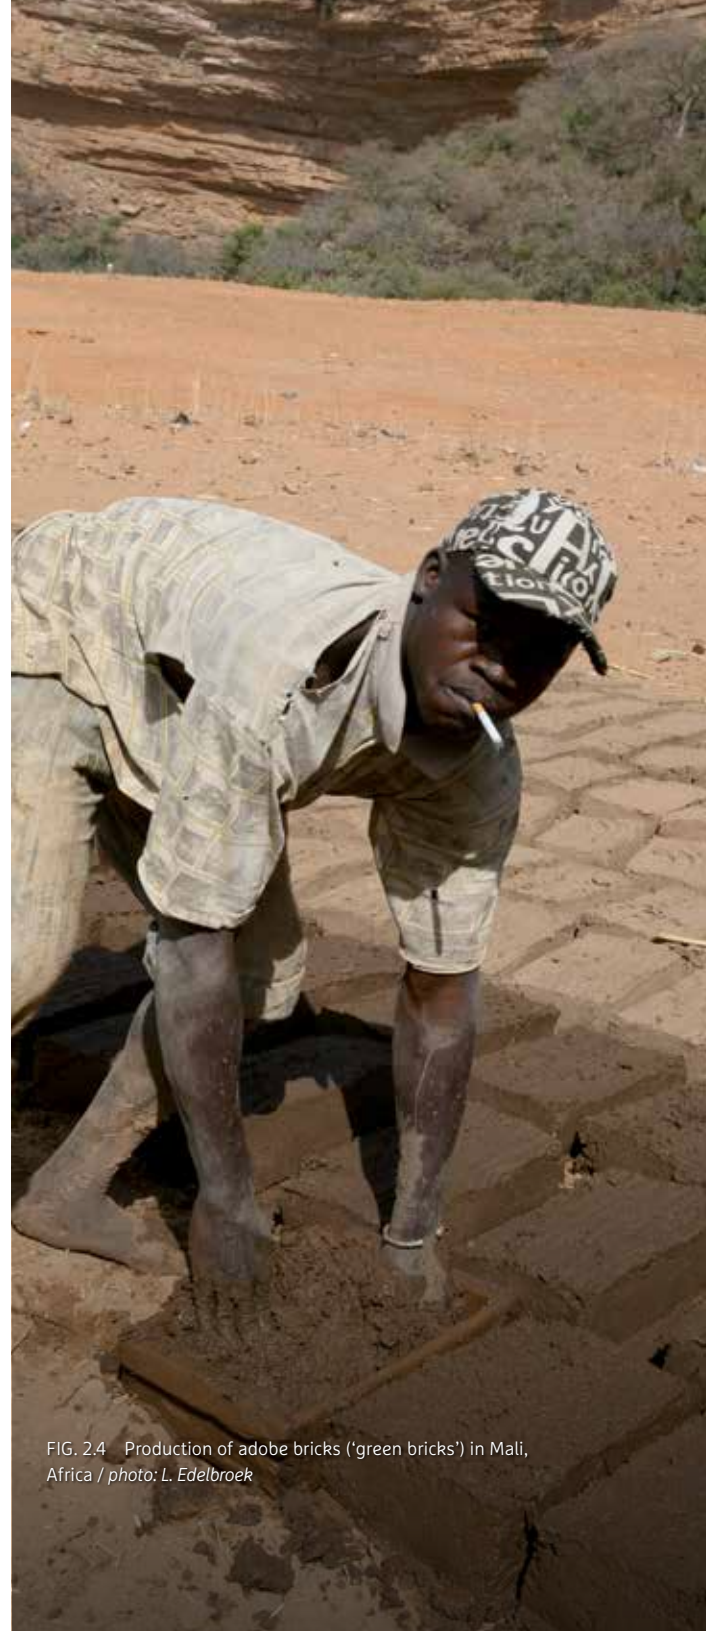
FIG. 2.4 Production of adobe bricks ('green bricks') in Mali, Africa / photo: L. Edelbroek

Mali is situated in the centre of the African continent. In Mali adobe has always been the traditional building material; adobe bricks are shaped by hand in a simple mould and then left to dry in the sun [FIG. 2.4]. Plain residential dwellings but also important public buildings like mosques were traditionally constructed in this material [FIG. 2.5]. Adobe walls are rendered with the same material adobe bricks are made of and need regular maintenance. The wooden beams protruding from the façade of the mosque and resulting in a quite expressive architecture [FIG. 2.5], fulfil a clear role in these maintenance activities: whenever substitution or repair of plaster is necessary, the plasterers will use the beams to sit upon during their work. This is a good example of early and natural integral approach to architecture, whereby the means of performing the foreseen maintenance are incorporated in the design and become thus a form of connection between the representative building and the local community.

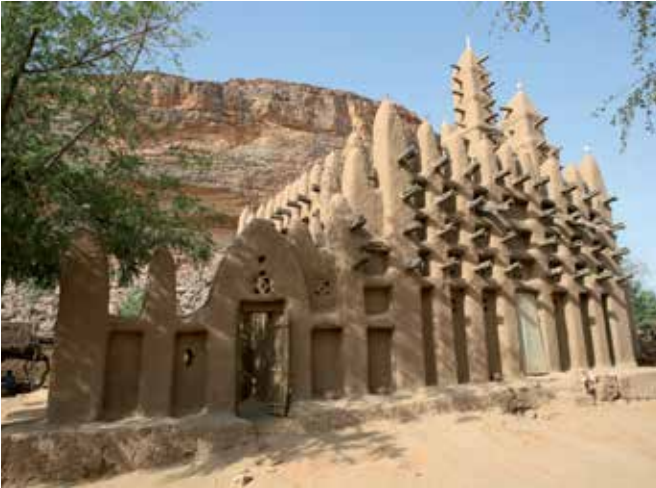
FIG. 2.5 Adobe brick construction, rendered with adobe; the wooden beams protruding from the walls are used for maintenance activities (mosque in Mali, Africa) / photo: L. Edelbroek

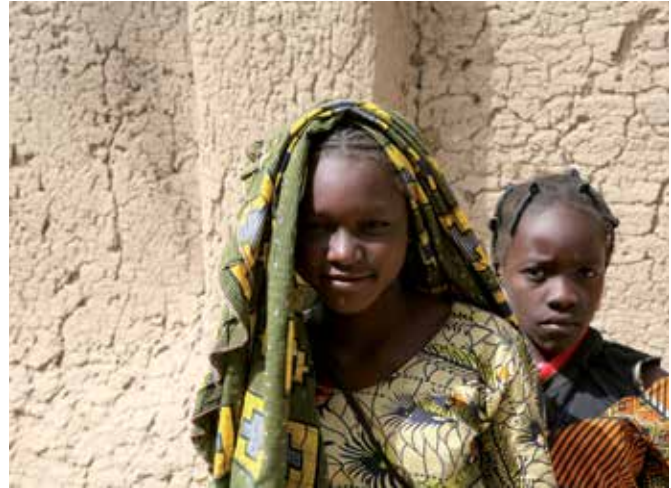
FIG. 2.6 Crack patterns, like crazing, can easily occur in the adobe rendering of external walls (Mali, Africa) / photo: L. Edelbroek

In the very warm and dry period from November to May, the adobe plaster is due to undergo a strong drying shrinkage, resulting in the occurrence of crack patterns (crazing), which makes – as already explained – a regular maintenance most necessary [FIG. 2.6].

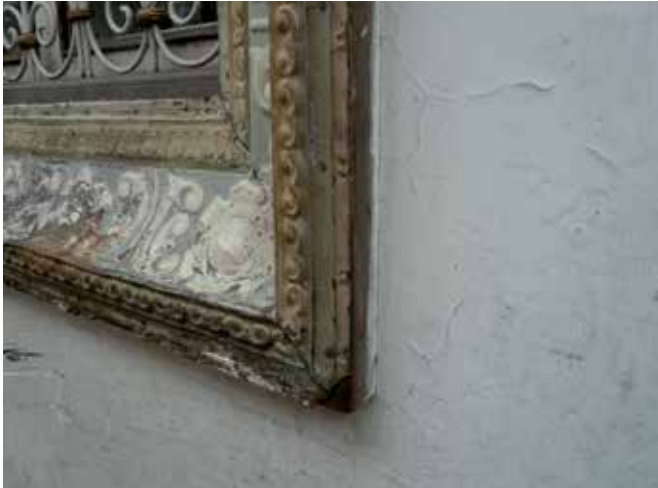
FIG. 2.7 Detail of window frame (casa Palomas, Cuenca, Ecuador) / photo: R. v. Hees

In recent years, hoping to make maintenance easier, modern paints have been applied as well, which, however, in most cases do not perform adequately and are moreover difficult to be removed without damaging the substrate [FIG. 2.7, FIG. 2.8].

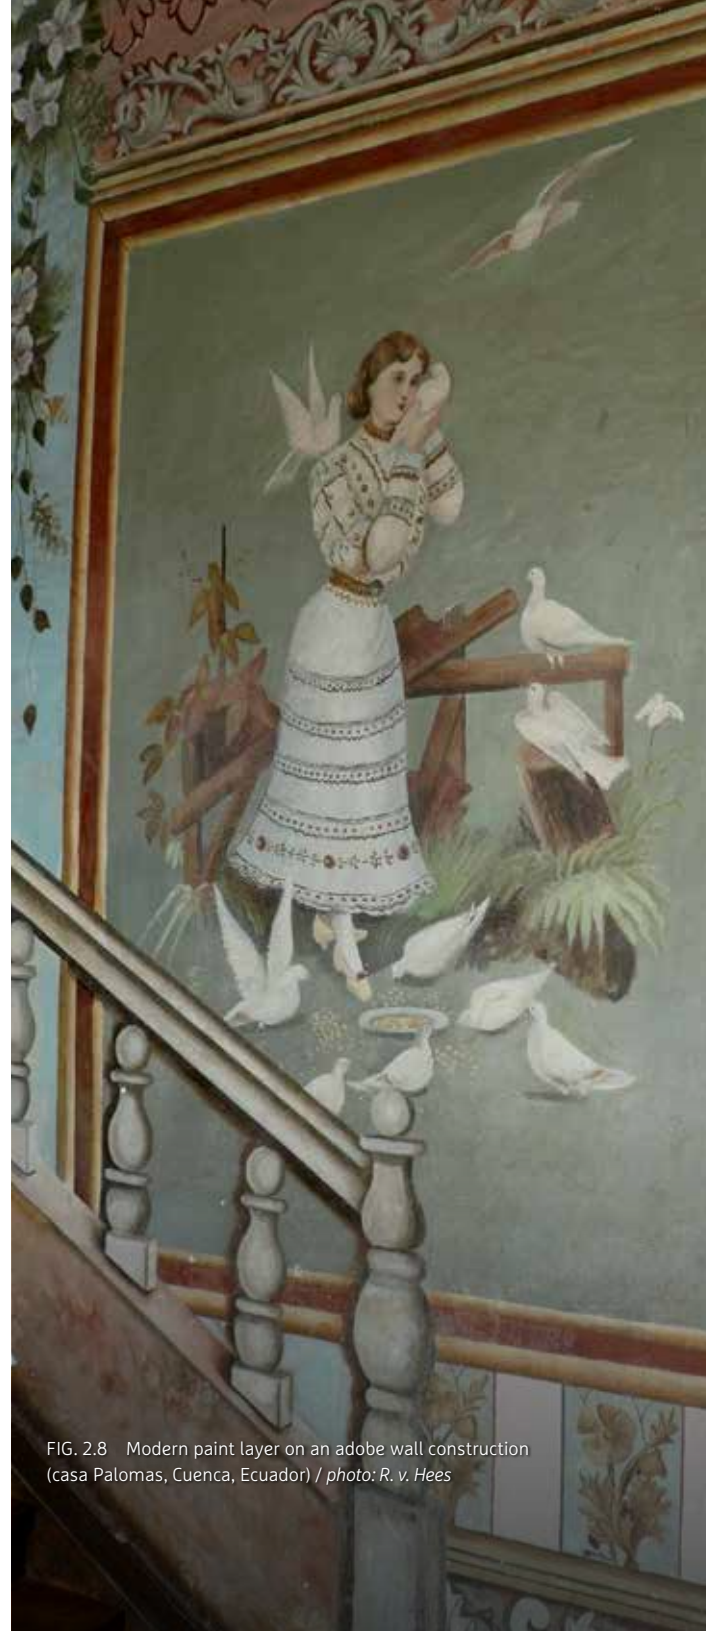
FIG. 2.8 Modern paint layer on an adobe wall construction (casa Palomas, Cuenca, Ecuador) / photo: R. v. Hees

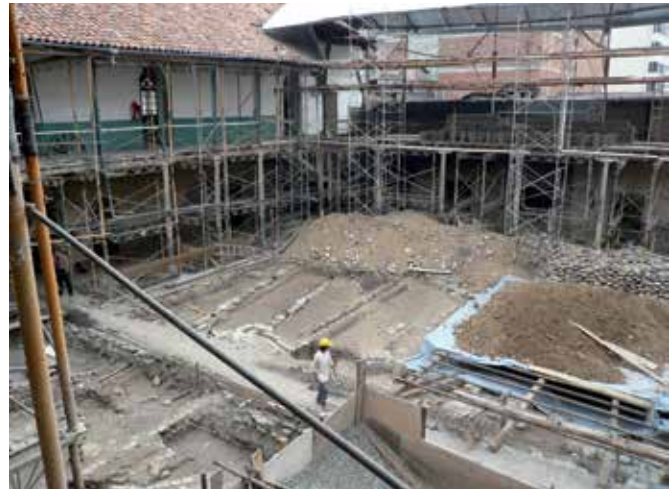
FIG. 2.9 Use of adobe in a restoration in Cuenca. The old material of a collapsed wing of the building is collected for re-use (house in Cuenca, Ecuador) / photo: R. v. Hees

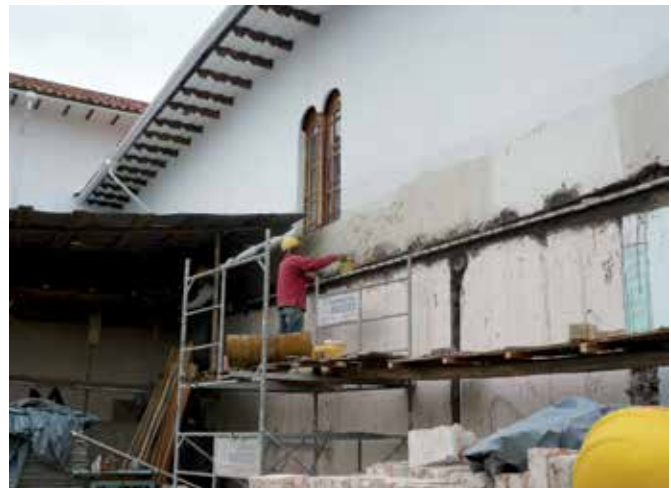
FIG. 2.12 Use of adobe for renders in a recent restoration (2010) (building in Cuenca, Ecuador) / photo: R.v. Hees

Renders need maintenance and are renewed with adobe prepared on the spot. [FIG. 2.11, FIG. 2.12, FIG. 2.13, FIG. 2.14].

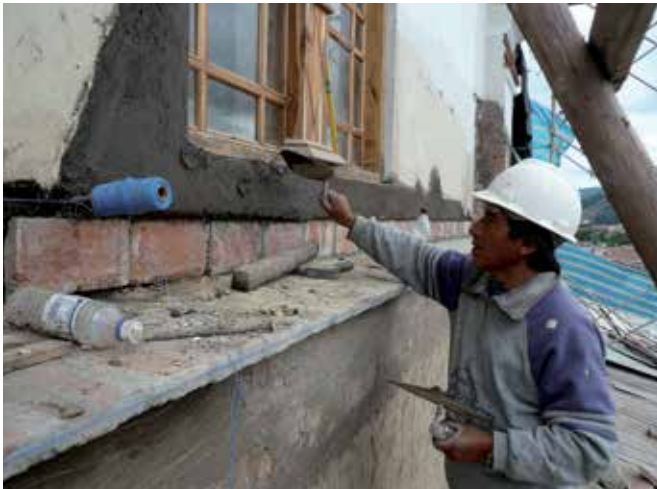
FIG. 2.10 A layer of brick masonry has been applied to better deal with the rainwater that can gather at the horizontal cornice (building in Cuenca, Ecuador) / photo: R. v. Hees

FIG. 2.10 shows how sometimes new materials are introduced in the construction, like a layer of brick masonry, however always acting in line with the tradition. The layer of brick masonry in this example, near horizontal surfaces like cornices that might collect rainwater, is used with the purpose of avoiding a quick decay of the adobe wall. Traditionally, rubble stone masonry is used at the ground level to minimize the effect of splash-up water and moisture from the soil [FIG. 2.11].

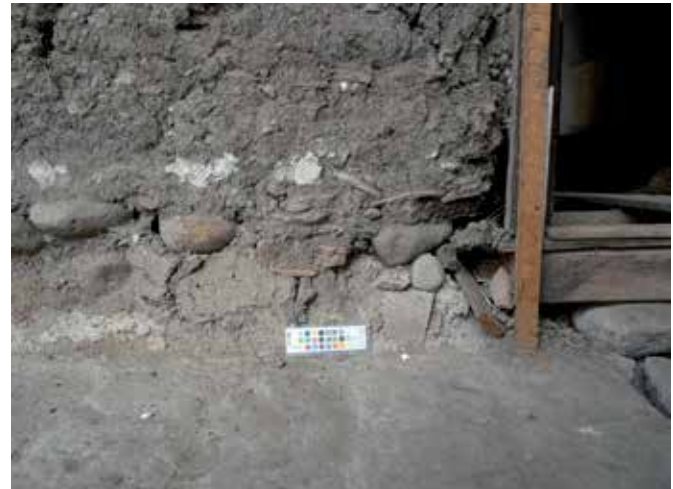
FIG. 2.11 Rubble stone masonry is used at the ground level to minimize the effect of splash-up (building in Cuenca, Ecuador) / photo: R. v. Hees

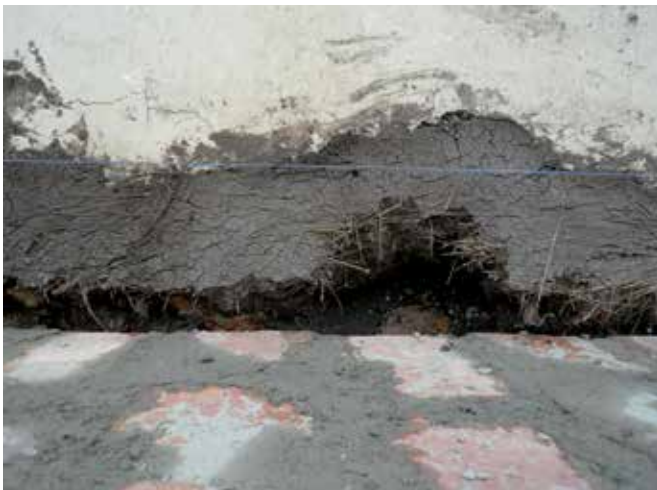
FIG. 2.13 Use of adobe for renders in a recent restoration (2010) (building in Cuenca, Ecuador) / photo: R.v. Hees

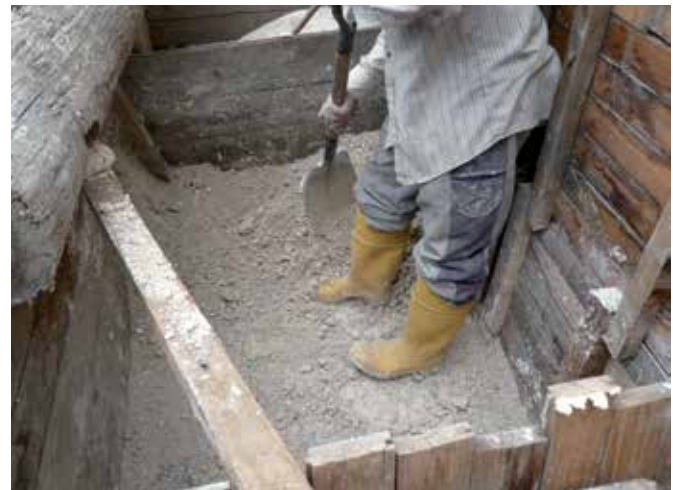
FIG. 2.14 Production of adobe for renders in a recent restoration (2010) (building in Cuenca, Ecuador) / photo: R.v.Hees

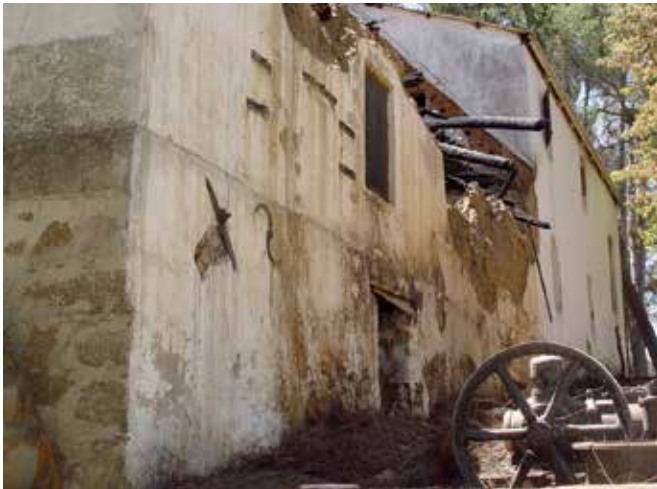
FIG. 2.16 Lack of maintenance (dwelling, Genadendal, South Africa) / photo: L.Verhoef

The technical part of the project consisted in a careful implementation of new materials and construction elements where the traditional ones had suffered from severe deterioration caused by the natural environment and lack of maintenance [FIG. 2.16]. The weak soil had been the origin of settlement cracks, and large floods, made more severe by the location, surrounded by hills, had led to moisture related decay at the lower parts of the walls.

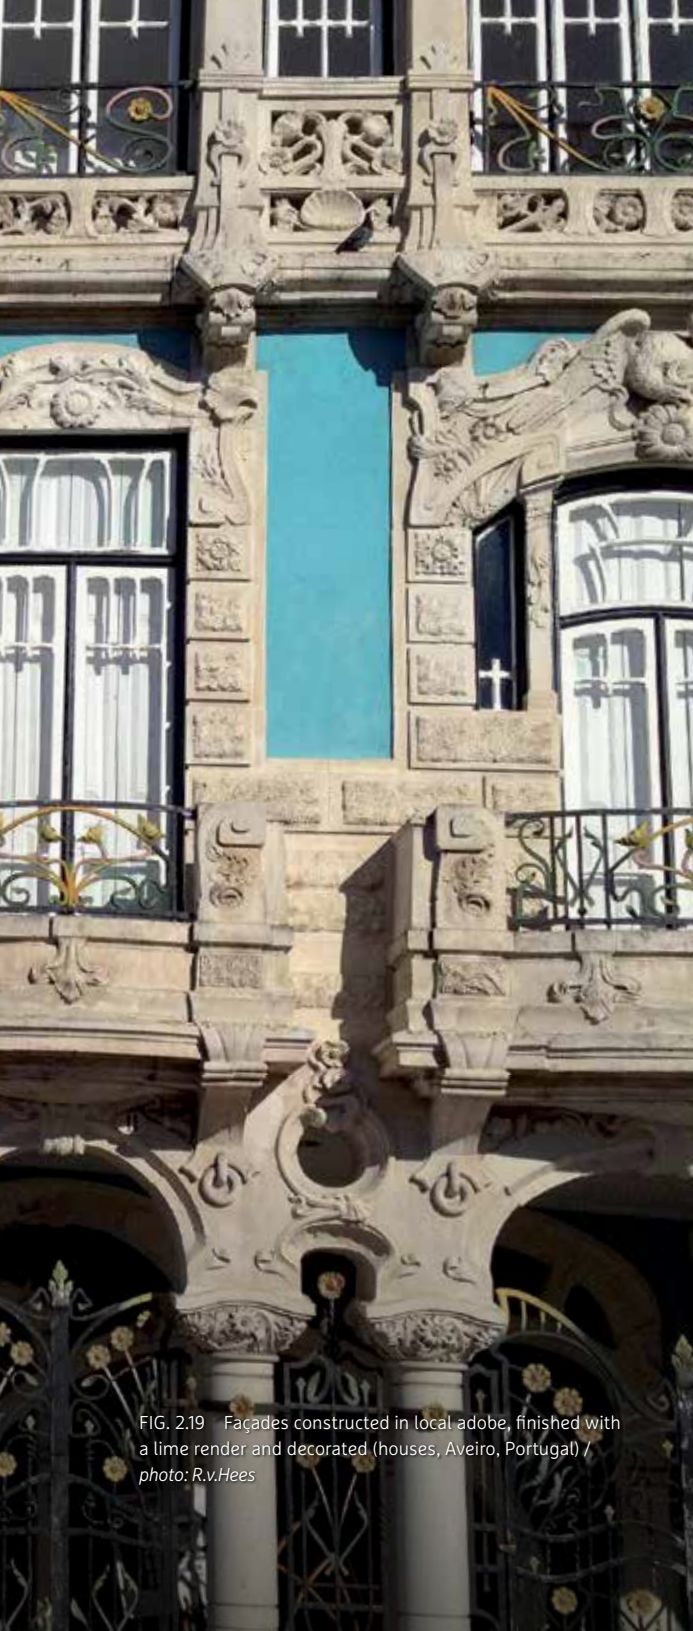
FIG. 2.19 Façades constructed in local adobe, finished with a lime render and decorated (houses, Aveiro, Portugal) / photo: R.v.Hees

The walls are finished with a lime render, which can be smooth and simple or beautifully decorated [FIG. 2.18, FIG. 2.19].

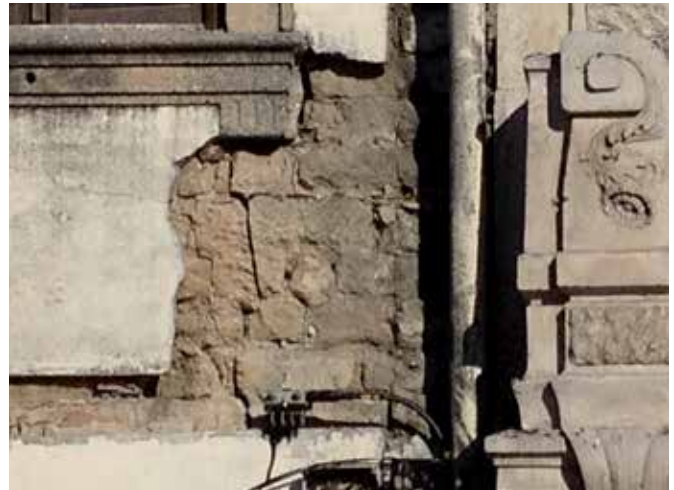
FIG. 2.18 Detail of façade constructed in local adobe and finished with a lime render (houses, Aveiro, Portugal) / photo: R.v.Hees

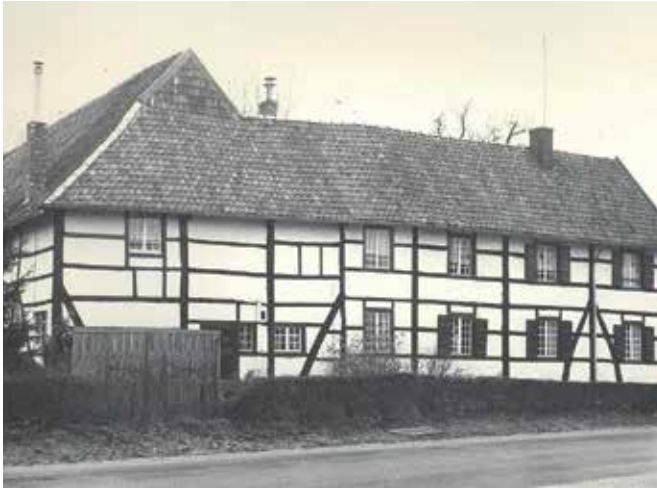
FIG. 2.20 The timber frame buildings originally had an infill of wattle and daub on a wooden lattice (house, south of Limburg, The Netherlands) / photo: R. v. Hees

A more or less adobe like material is used as a kind of infill in the squares or panels of timber frame buildings, which are to be found in many parts of Europe, including the UK, the German Eifel and the Dutch province of Limburg. The infill is traditionally called *wattle and daub*. In this type of construction, a woven wooden lattice (branches of trees: thin branches -either whole, or more usually split- or slats between upright stakes) is daubed with a mortar, traditionally consisting of clay, sand and animal excrements [FIG. 2.20].

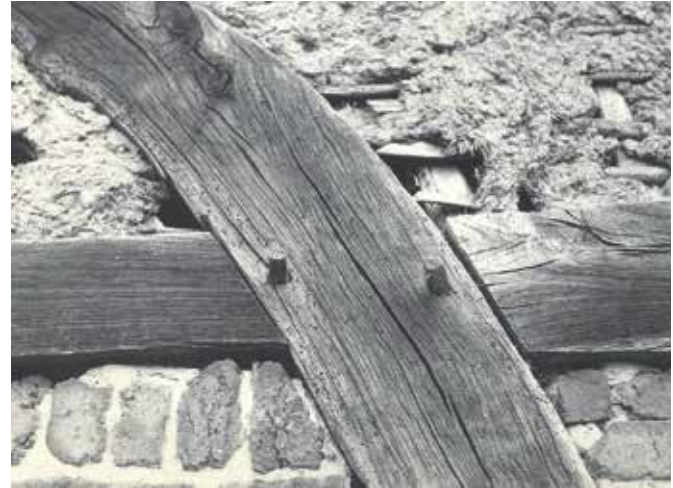
FIG. 2.21 Wattle and daub on a wooden lattice (house, south of Limburg, The Netherlands) / photo: R. v. Hees

The last example shows the use of a similar raw material (earth / adobe) within a different local tradition (the use of timber frames); the careful way of using the scarce, local resources is however quite comparable [FIG. 2.21].

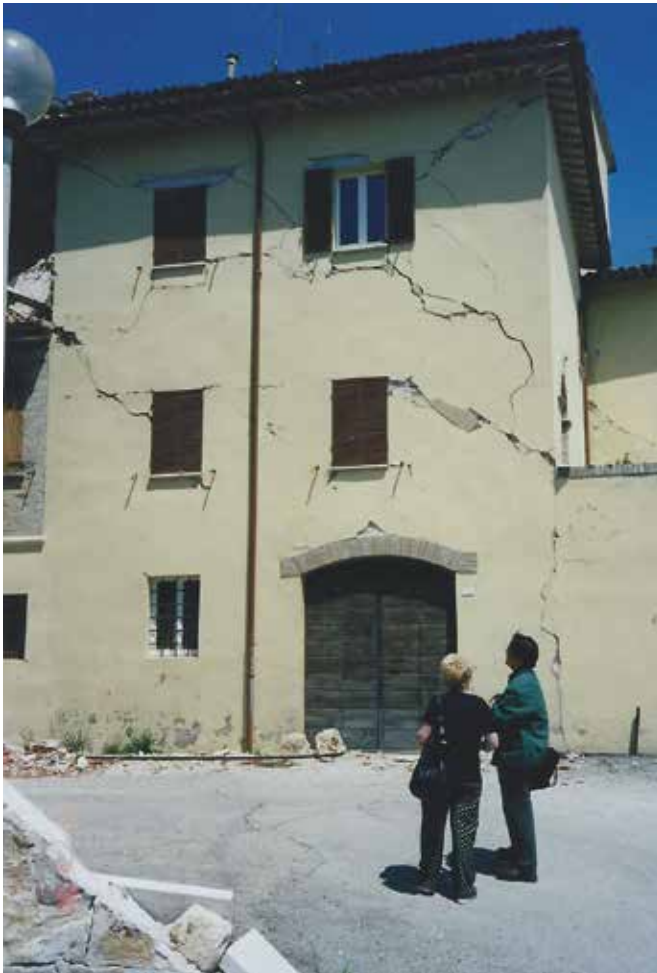
FIG. 3.1 Typical earthquake damage pattern: diagonal cracks in two different directions and X shaped cracks (house, Umbria, Italy) / photo: R. v. Hees

Earthquakes may result in very severe damage to historic building constructions. Especially in solid masonry and rubble-stone walls, generally without so-called ‘through stones’. In those cases damage patterns like diagonal cracks or the collapse of the central parts of relatively slender walls often occur.

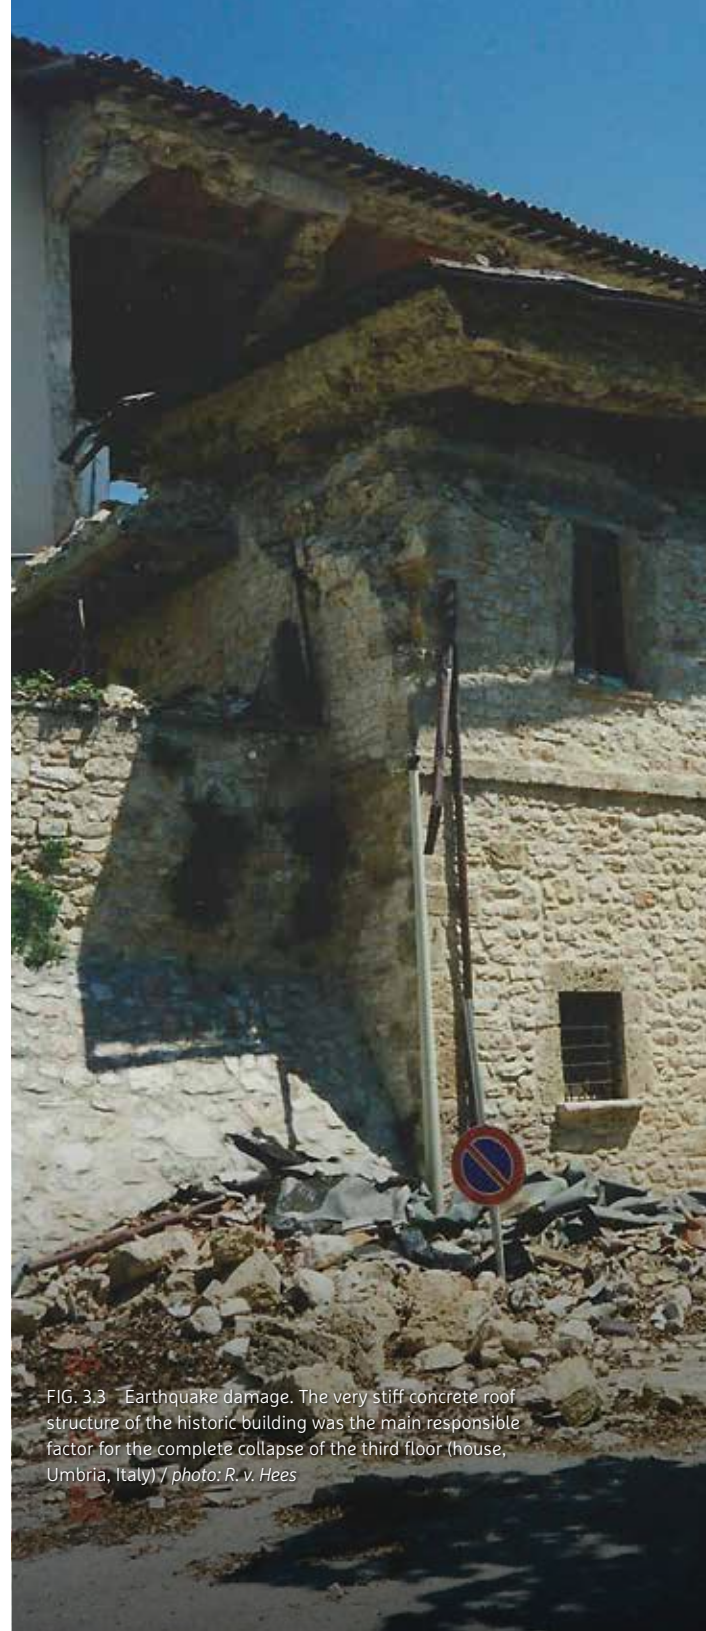
FIG. 3.3 Earthquake damage. The very stiff concrete roof structure of the historic building was the main responsible factor for the complete collapse of the third floor (house, Umbria, Italy) / photo: R. v. Hees

Some of the severely damaged buildings suffered the consequences of 'anti-seismic' interventions with non-compatible materials and construction parts. An example of this approach is the concrete roof of a historic building, which had been added as an anti-seismic measure, but turned out to enhance risk dramatically, during the next earthquake, when it even caused the collapse of the whole third floor (FIG. 3.3).

The collapse was due to the fact that the roof construction was far too stiff in relation with the relatively weak historic masonry wall construction. Instead of the new roof being an effective kind of confinement of the walls, as it had been assumed, it led to their failure.

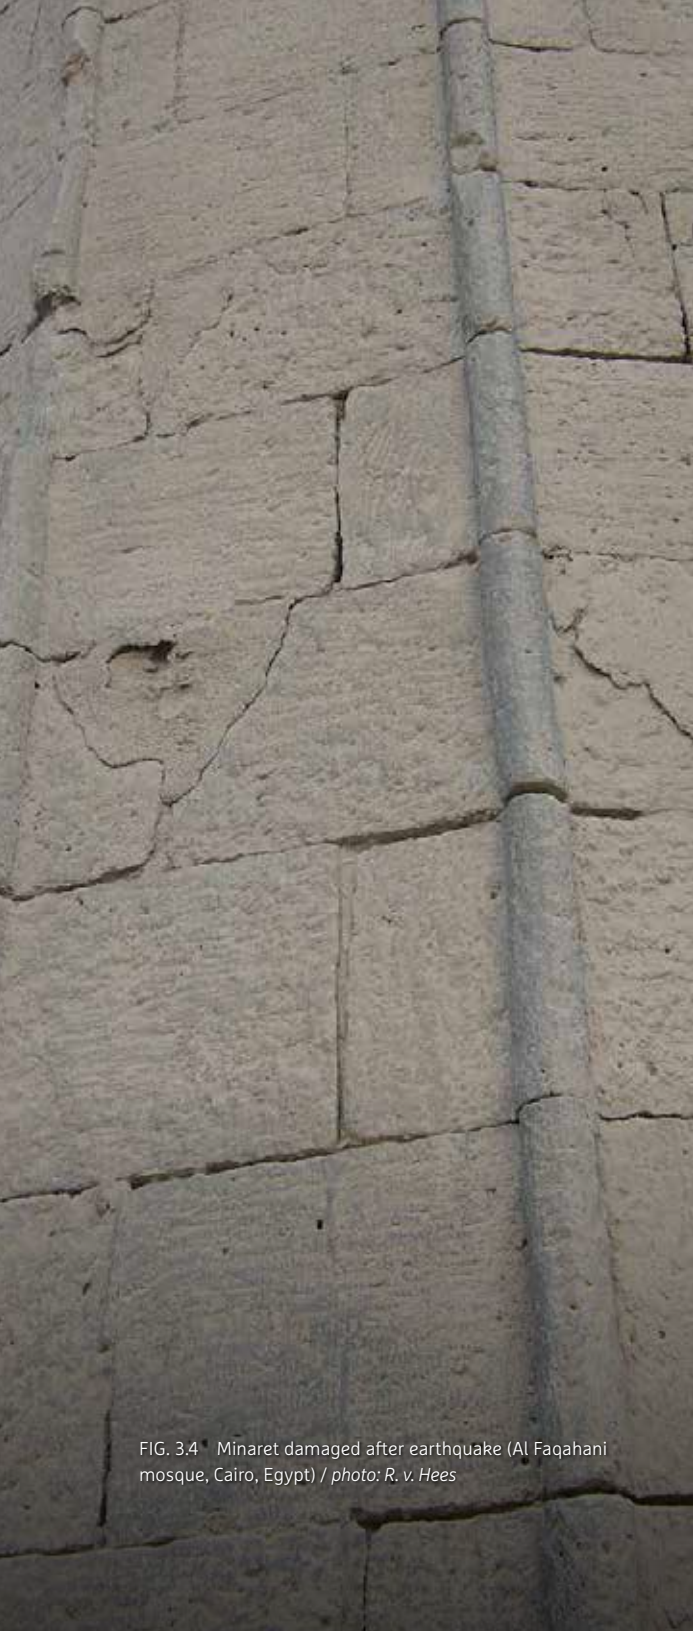
FIG. 3.4 Minaret damaged after earthquake (Al Faqahani mosque, Cairo, Egypt) / photo: R. v. Hees

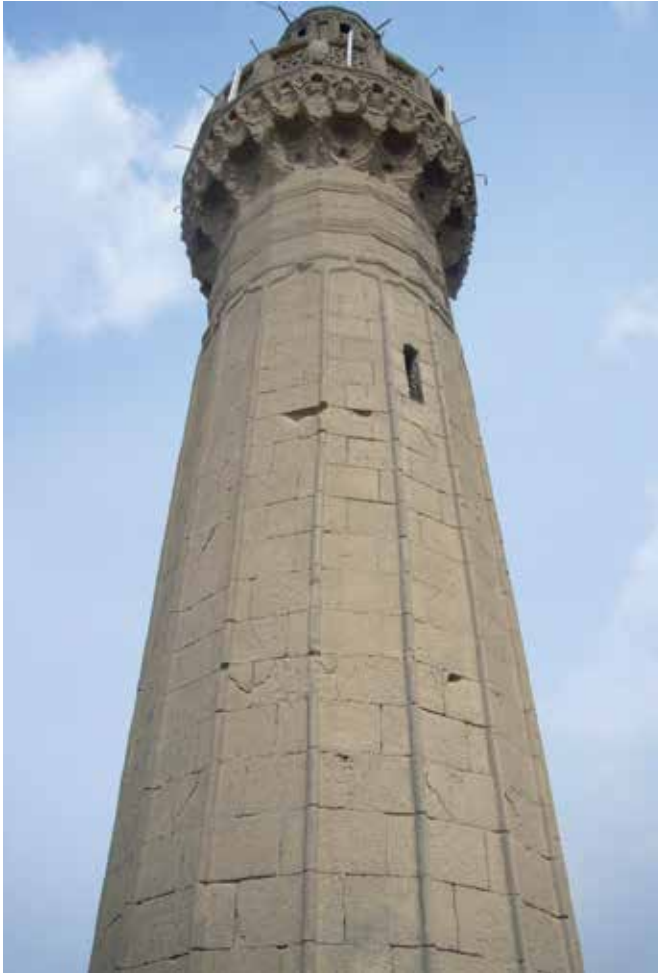
FIG. 3.5 Diagonal cracks in different directions, visible after the 1992 earthquake (minaret, Al Faqahani mosque, Cairo, Egypt) / photo: R. v. Hees

The city of Cairo (Egypt) is situated in an earthquake zone. The 1992 Cairo earthquake had its epicentre near Dahshur, a royal necropolis, situated at the west bank of the Nile, ca. 35 km south of Cairo and a magnitude of 5.8 on the Richter scale. Although this value is not extremely high, the earthquake was unusually destructive. It caused about 545 deaths and made 50000 people lose their home. For Cairo, this was the most damaging seismic event since 1847<sup>7</sup>. Some examples of structures suffering from earthquake damage, are the minaret of Al Faqahani mosque [FIG. 3.4, FIG. 3.5] and the nearby sabil, a historic public drinking fountain [FIG. 3.6].

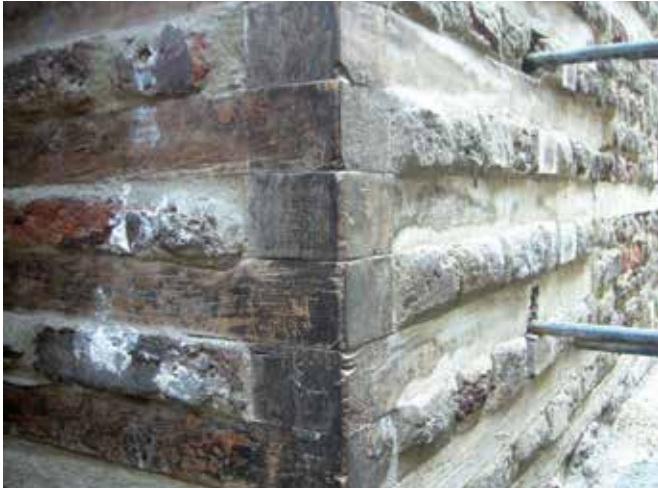
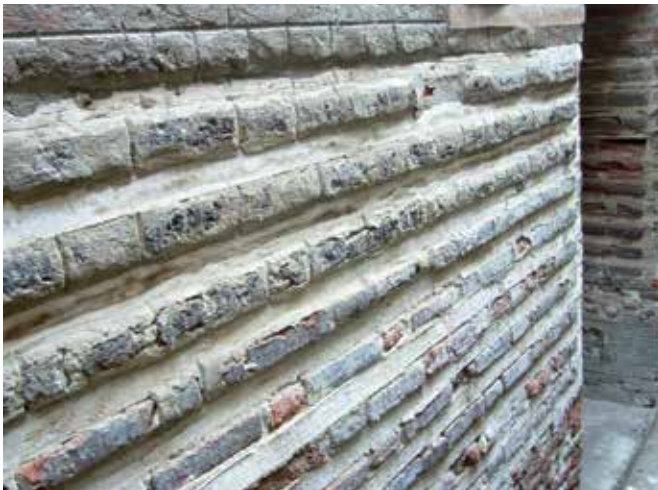
FIG. 3.7 Combination of brick and timber layers in the lower part of masonry walls (building, Coptic quarter, Cairo, Egypt) / photo: R. v. Hees

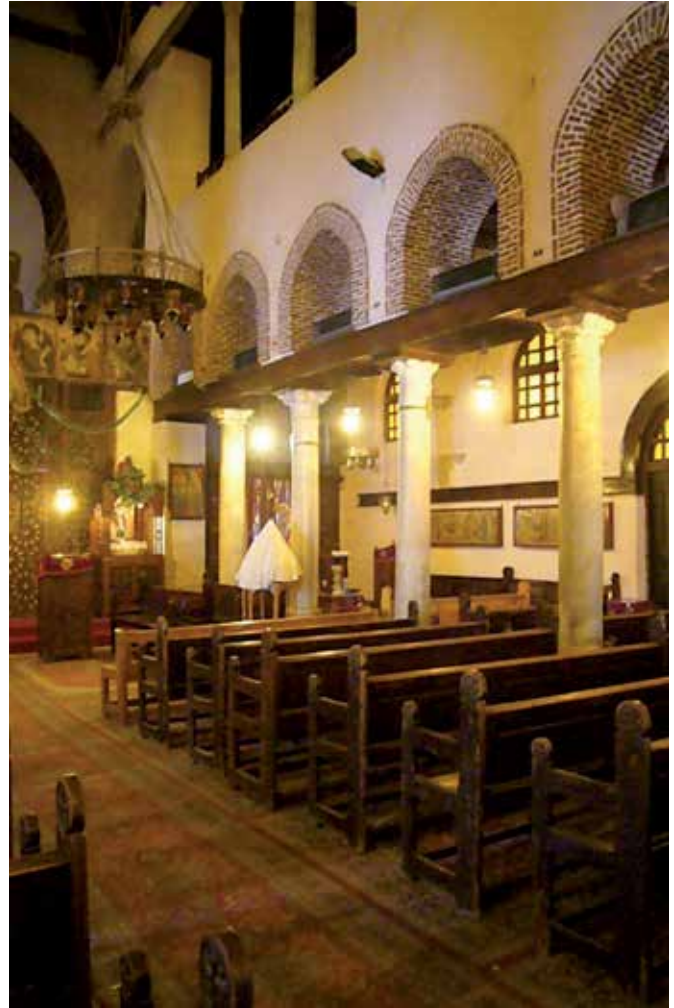
FIG. 3.8 Timber beam supporting the arches and contributing to the ductility of the structure (Coptic church, Cairo, Egypt) / photo: R. v. Hees

To be noticed is also the timber beam supporting the arches of a Coptic church, which contributes to increase the ductility of the structure [FIG. 3.8].

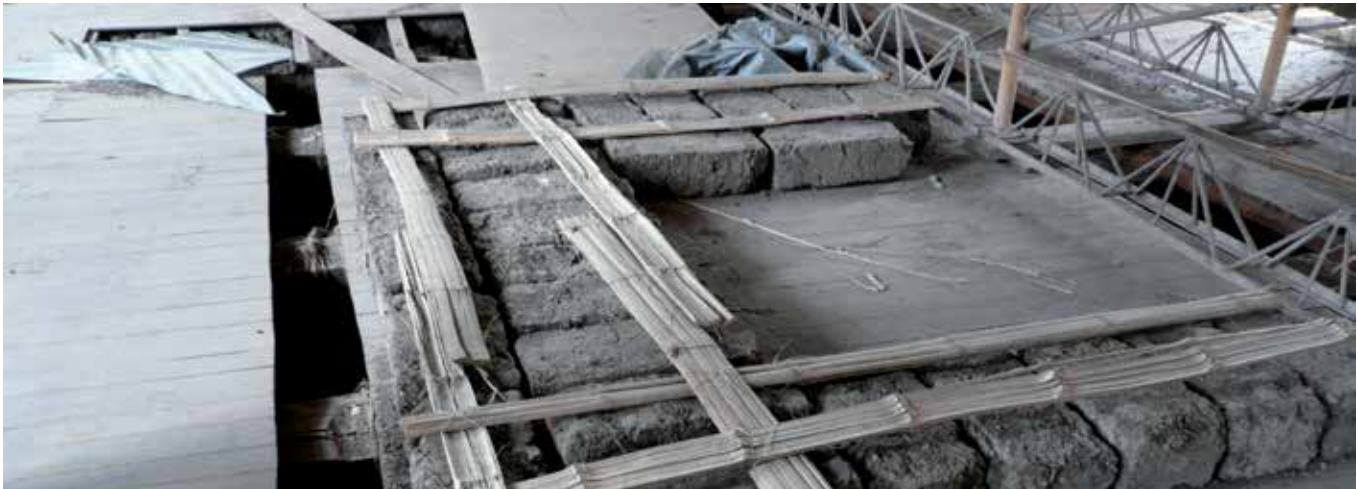
FIG. 3.9 Bamboo ready to be used as a ductile reinforcement in adobe walls (school building, Cuenca, Ecuador) / photo: R. v. Hees

The principle based on the ductility of materials can be found back in solutions applied in constructions all over the world. In the 2009 restoration of a historic school building in Cuenca (Ecuador) one of the intervention measures consisted of the introduction of bamboo as a ductile corner reinforcement of the adobe wall constructions [FIG. 3.9].

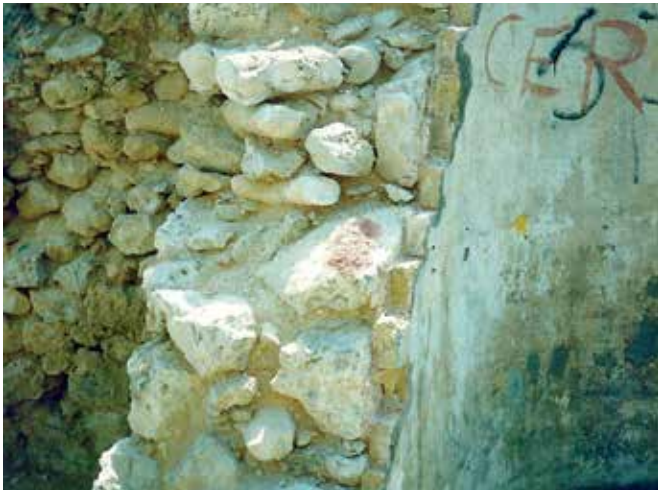
FIG. 4.3 Composition of a cistern wall: coral stone wall construction with an internal cladding of 'Jssel clinkers' and a two or three layer render system on the inside (Curaçao, Caribbean) / photo: R. v. Hees

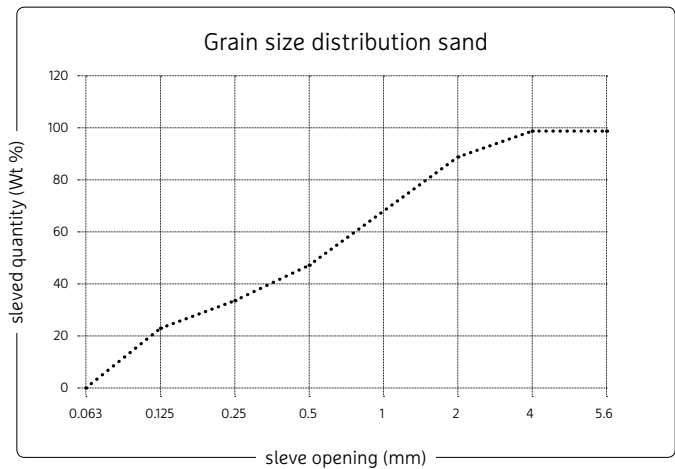
FIG. 4.4 Grain size distribution traditional crushed limestone sand; note the high percentage (ca. 25%) finer than 0.125 mm [Hees v. 2005]

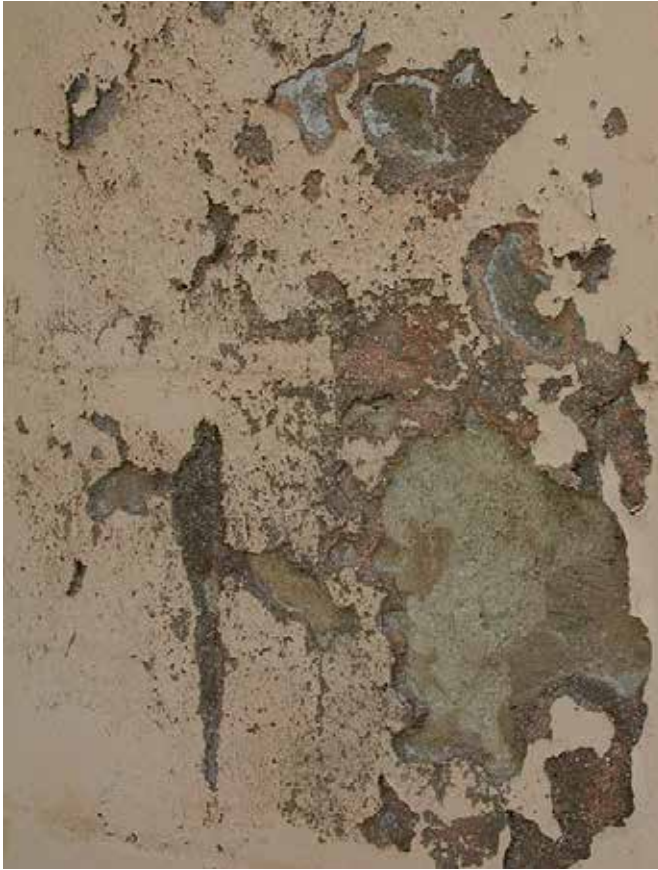
FIG. 4.5 With the use of 'better', more durable materials, sometimes damage is induced: here the plaster shows loss of cohesion (building, Curaçao, Caribbean) / photo: R.v.Hees

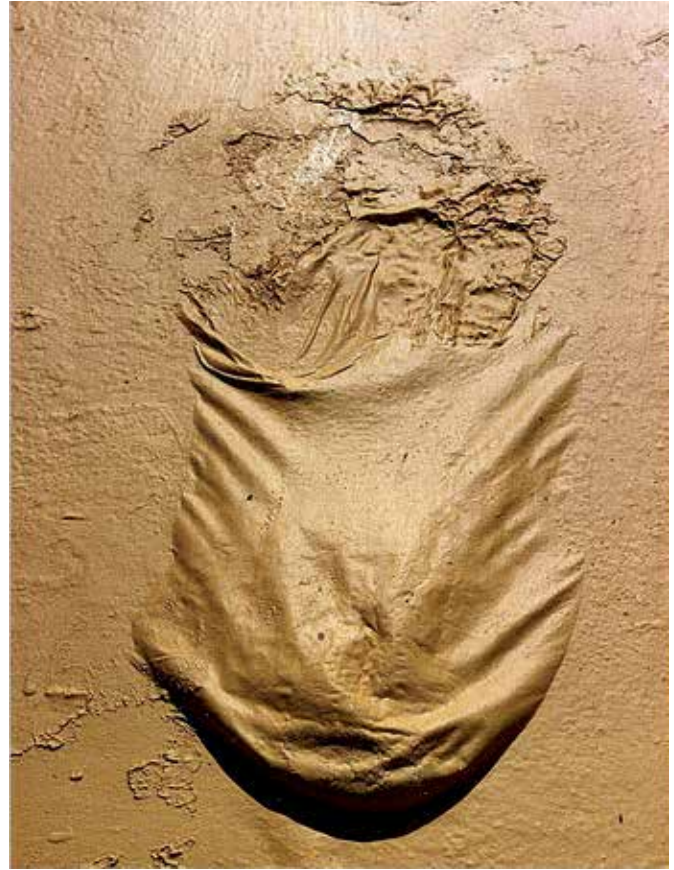
FIG. 4.6 Blistering of latex paint (detail of a painted plaster, house, Curaçao, Caribbean) / photo: R.v.Hees

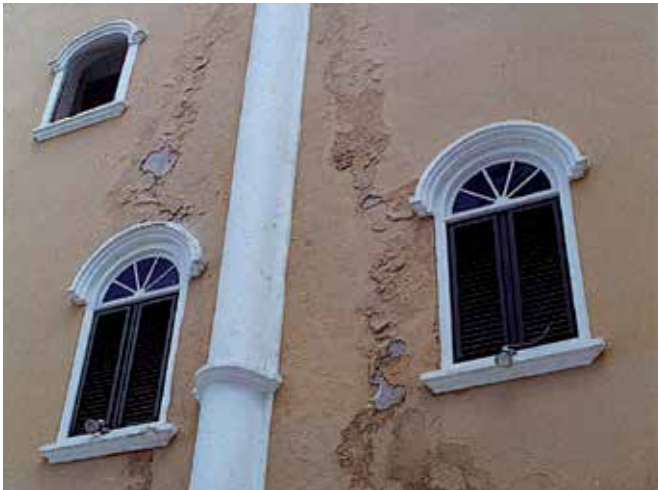
FIG. 4.7 Damage to the plaster (synagogue, Curaçao, Caribbean) / photo: R. v. Hees

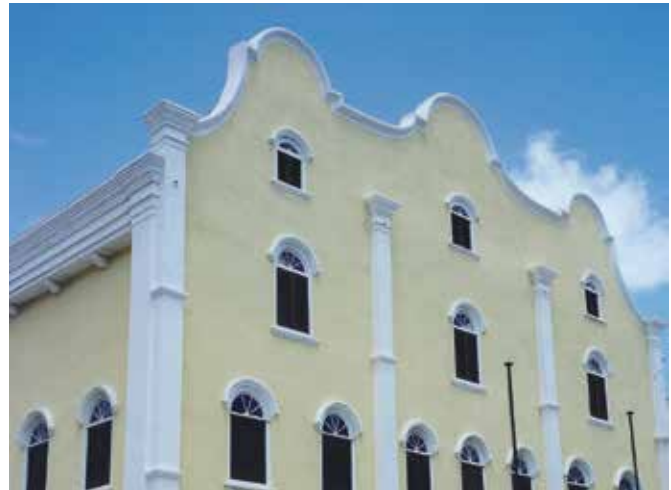
FIG. 4.8 Façade furnished with a salt resistant render system in 1994, situation 6 years later (synagogue, Curaçao, Caribbean) / photo: R. v. Hees

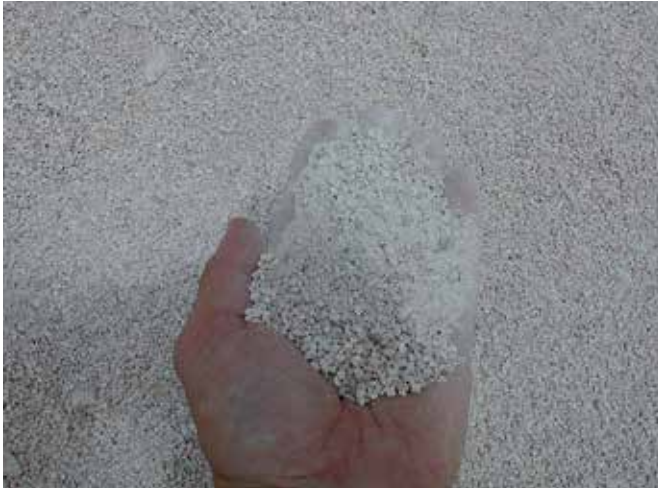
FIG. 4.9 The crushed limestone sand from the mine company at Curaçao, with quite some very fine grains / *photo: R. v. Hees*

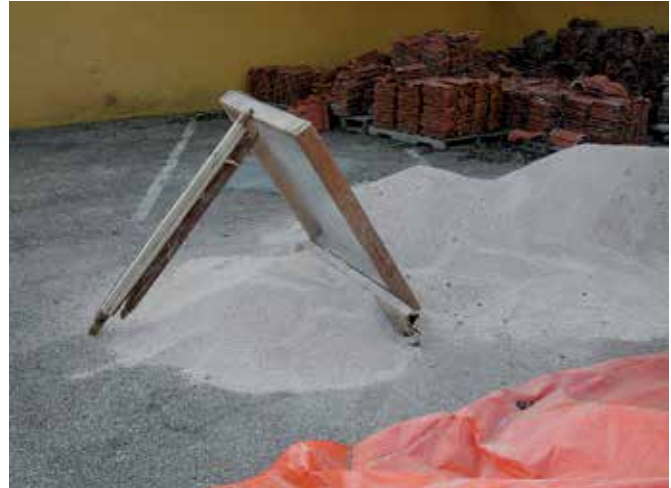
FIG. 4.10 Sieving, even with simple means, results in rather coarse grained sand, as a basis for plasters that turned out to be better salt resistant. The remaining fine sand fraction can be used for other types of plaster and as a filler in other applications / *photo: R. v. Hees*

One of the research lines that has been investigated, was the use of local sand. The grain sizes of the sand, largely determine the size of the pores that will form in the plaster and consequently also its behaviour in terms of moisture and salt transport. Taking the finer sand fractions out, a more favourable pore size distribution was obtained [FIG. 4.9, FIG. 4.10]. The fractions used for the realization of the new mortar designs are shown in FIG. 4.11.

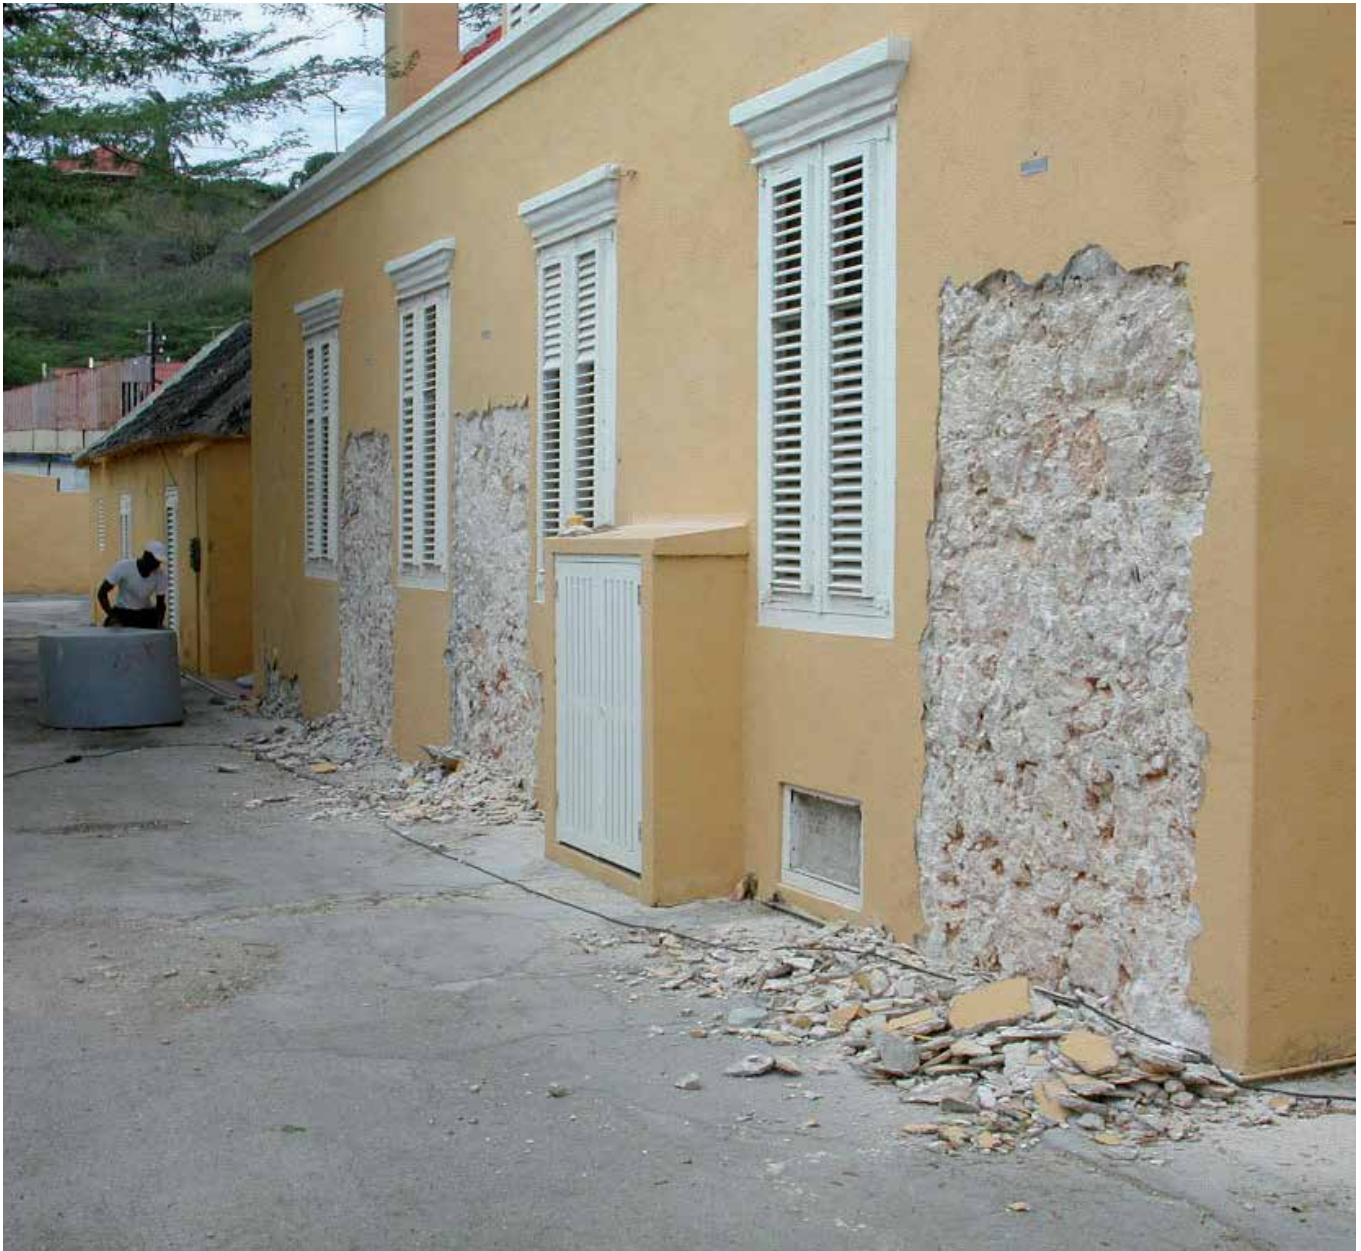
FIG. 4.12 Preparation of test panels (house at Charloo, Curaçao, Caribbean) / photo: R. v. Hees

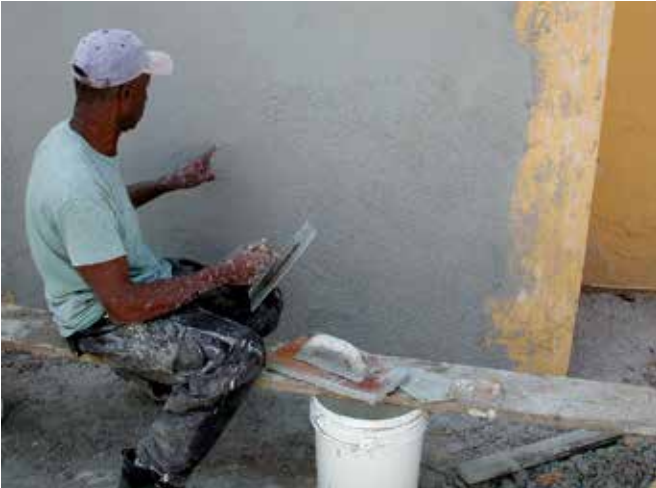
FIG. 4.13 Newly designed render compositions with assumed better salt resistant behaviour (house at Charloo, Curaçao, Caribbean) / photo: R. v. Hees

Once a promising design of a mortar mix has been achieved, aiming for a better salt resistant plaster, extensive tests are necessary. These include accelerated tests in laboratory and the application and monitoring of the plaster in a number of test panels *in situ*. This is an essential part of the research, because here aspects like workability and finally also performance under practice conditions can become clear [FIG. 4.13, FIG. 4.14].

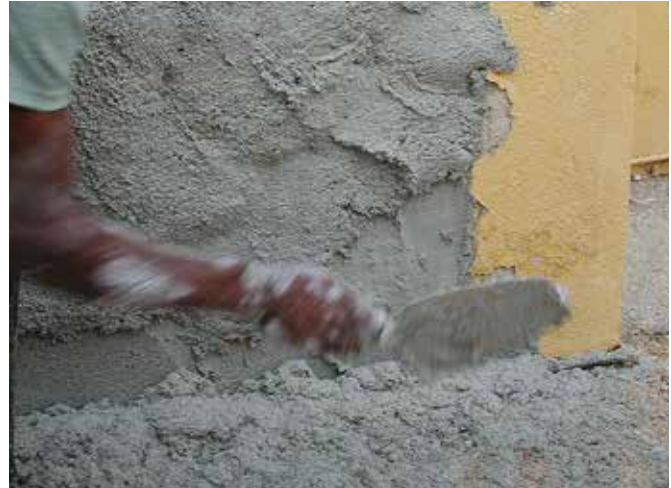
FIG. 4.14 Application of new render (house at Charloo, Curaçao, Caribbean) / photo: R. v. Hees
