# Durable past – sustainable future

Rob van Hees  
Silvia Naldini  
Job Roos

TU Delft OPEN  
Publishing

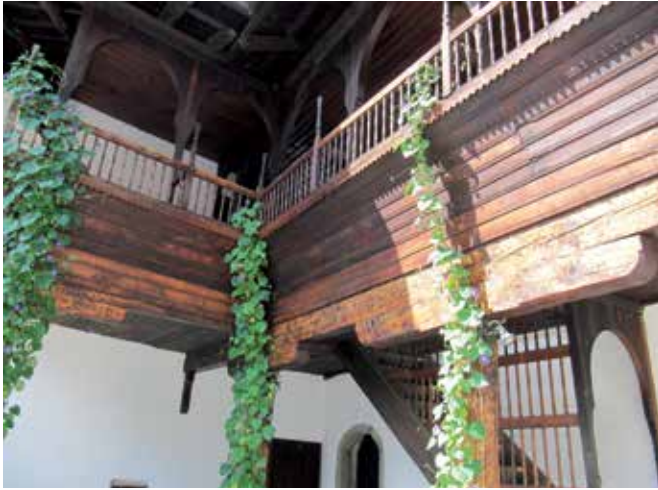
FIG. 5.5 Traditional veranda (Svrzo's House, Sarajevo, Bosnia) / photo: S. Op den Kamp

The houses (from ca. 1480 onwards) were constructed in a type of adobe, fabricated using local clay and straw, and the facades were white washed. In more recent times, beside adobe also fired brick was used. The ceilings were made of wood, and plaited wood was used to screen the sun. Other protections against the strong sun were formed by porches and roofs edges prolonged to form a veranda [FIG. 5.4]; the windows, rectangular in shape, were small. As already seen, when first describing vernacular architecture, also in the Islamic residential complexes sustainably was intrinsically present in the response to the environmental situation, both for what concerned the available materials and the climate. Such a climate design would not require any artificial cooling.

The *Mahala* tradition is still alive, as shown by the typology and the spirit of new buildings, furnished with yards and pergolas, substituting the traditional verandas, which like the old ones, are cool and pleasant places to be. The courtyard of the *Mahala* had also the very important function of forming a transitional space between inside and outside, private and public space, and as such represents a recurrent feature in the modern architecture of the city [FIG. 5.5, FIG. 5.6].

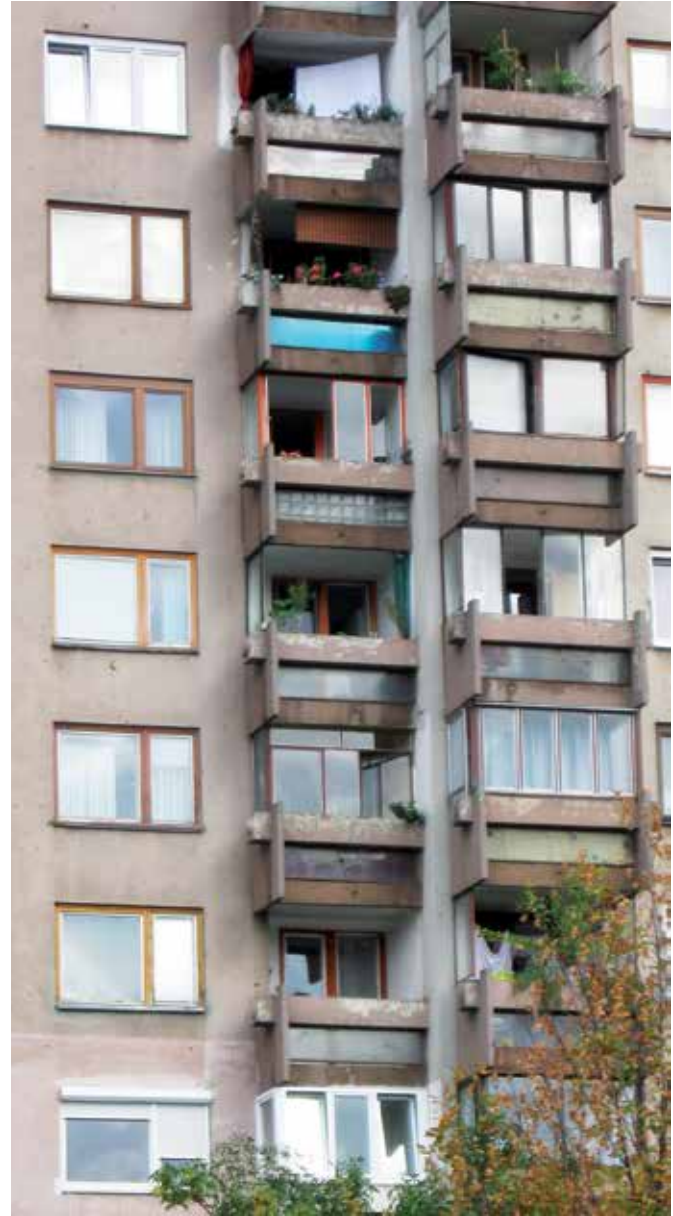
FIG. 5.6 Balconies of modern architecture. Modern balconies, like traditional ones, represent a transition area, between private and public sphere (apartment building, Sarajevo, Bosnia) / photo: M. Kasimidi

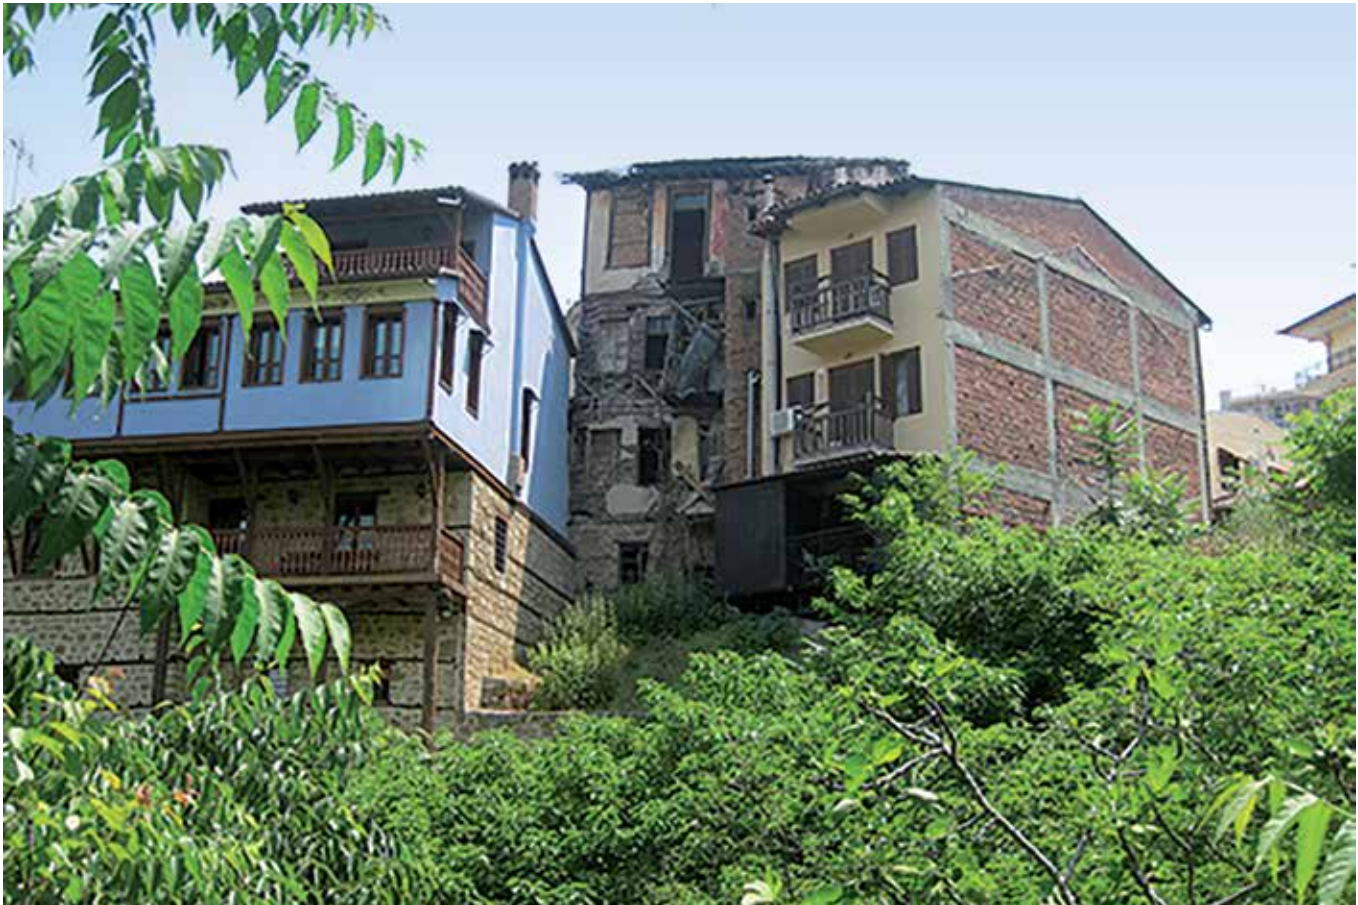
FIG. 5.10 Historical houses (Veria, Greece) / photo: K. Theologi

The churches date back to the 13<sup>th</sup> cent. and are sober outside, but decorated by frescos inside. The masonry, presently in a deteriorated state, due to lack of maintenance, shows an ingenious anti-seismic construction system. The walls are built in brick, a hand-made traditional material, with the insertion of wooden beams, meant to guarantee flexibility to the construction and thus better face the risk of earthquakes.

before planning any interventions. The vernacular, somehow imperfect character of the existing, should be the starting point to develop a line of intervention, using the solutions found in the past for making the existing durable, sustainable and suitable for living a modern life. Any restoration of the buildings should be aware of the sustainability of traditional building techniques and materials, and learn from the past how to handle with the present [FIG. 5.9, FIG. 5.10].

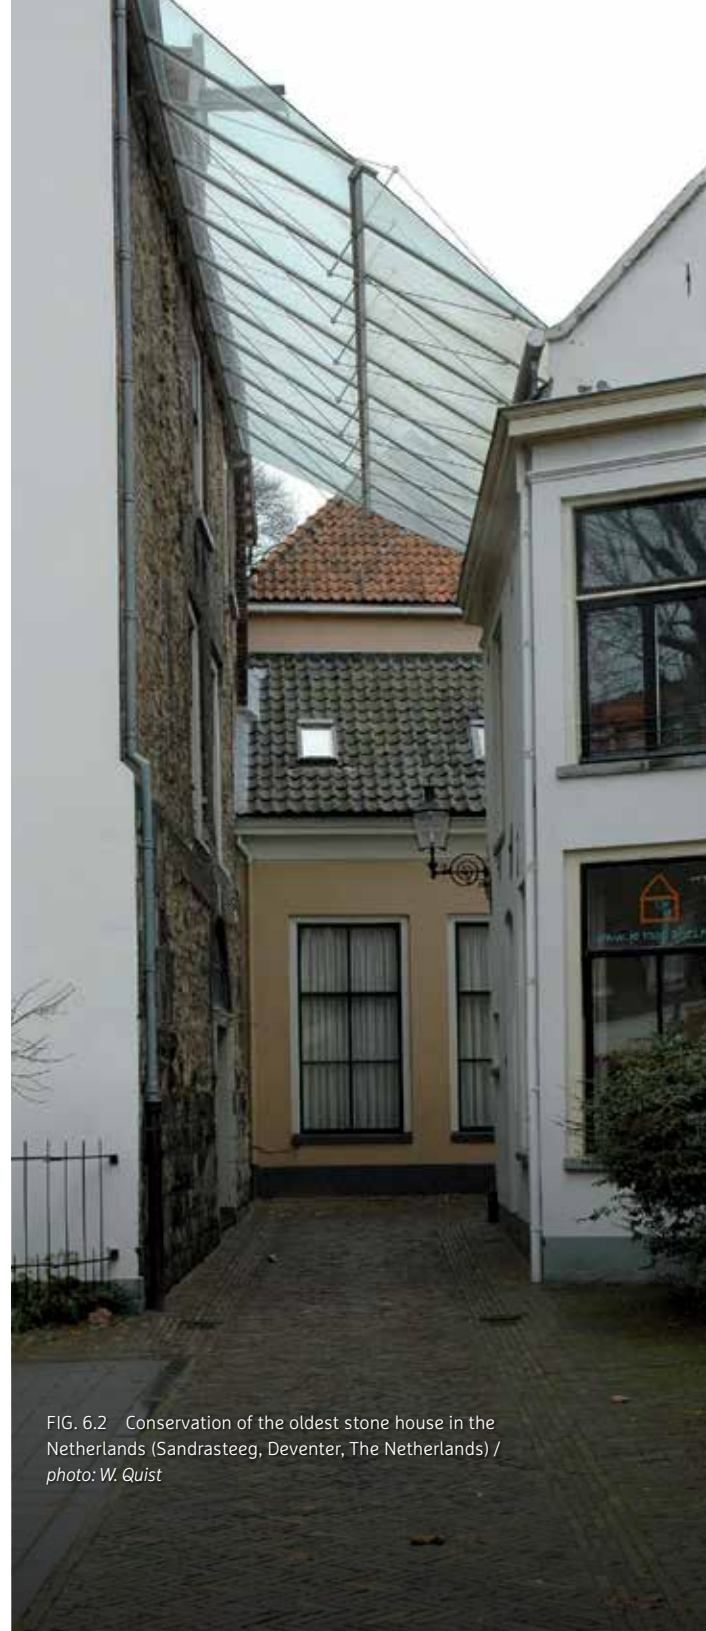
FIG. 6.2 Conservation of the oldest stone house in the Netherlands (Sandrasteeg, Deventer, The Netherlands) / photo: W. Quist

In old times, Deventer, a Hanseatic city, served as a staple-place of building materials, more specifically stone, transported from the Eifel region in Germany; main stone types were Römer tuff stone, already used by the Romans, and trachyte. This explains why tuff stone was used for the major buildings in Deventer, like the main churches and also the deanery. In the provost house the oldest parts consist of both tuff stone and trachyte.

Although Römer tuff stone is a quite weather resistant (durable) material, able to survive for centuries, a certain kind of weathering occurs after a long service life, making the material frost sensitive. During the restoration of 1991-1994<sup>9</sup> the treatment with a new consolidating agent was therefore considered. A stone consolidant is meant to reintroduce the internal coherence in a degraded material. However, from research carried out by TNO<sup>10</sup>, it became clear that even this treatment would not have been a guarantee for frost resistance. Instead, TNO suggested to make sure that any water penetration in the material would be avoided, water being the essential factor for frost damage to occur. The result was the design of a transparent glass roof by the restoration architect [FIG. 6.3]. The roof prevents the occurrence of a high water content in the tuff stone wall, without hindering the appreciation of the façade. Furthermore, such an intervention is fully reversible and also meant to avoid the use of chemicals and solvents. The intervention on the façade is transferred to the level of the architecture, thus stressing the importance of the historical object.

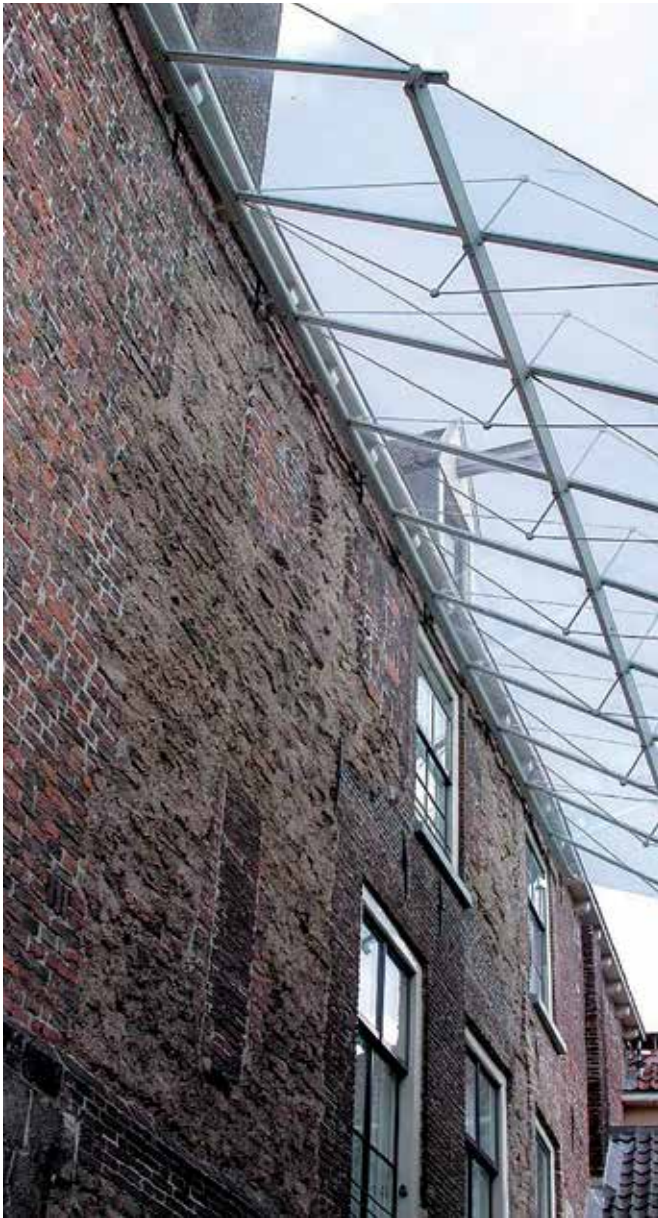
FIG. 6.3 Transparent roof construction as a protection for the tuffstone in the historic wall (house, Sandrasteeg, Deventer, The Netherlands) / photo: R. v. Hees

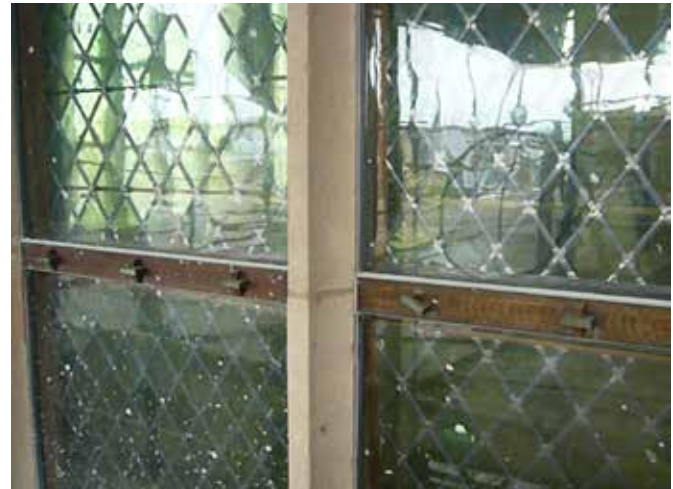
FIG. 6.6 Test panels for external glazing in front of the stained-glass windows (Peter's church, Leiden, The Netherlands) / photo: R. v. Hees

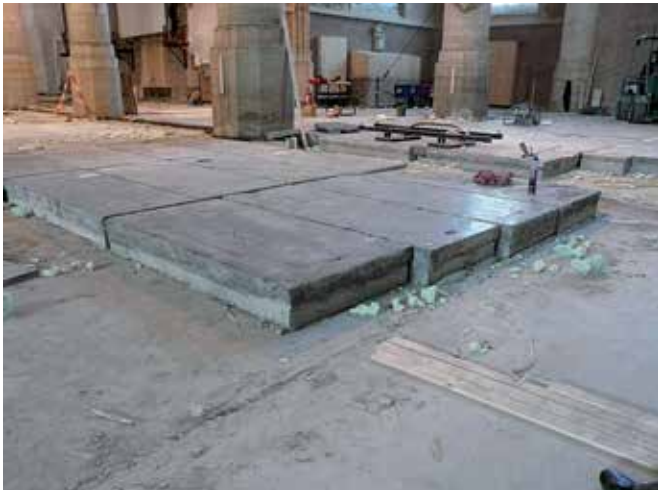
FIG. 6.7 The *petit granit* gravestones furnished with concrete layer to enhance thickness, lying on the special floor where the heating pipes run (Peter's church, Leiden, The Netherlands) / photo: R. v. Hees

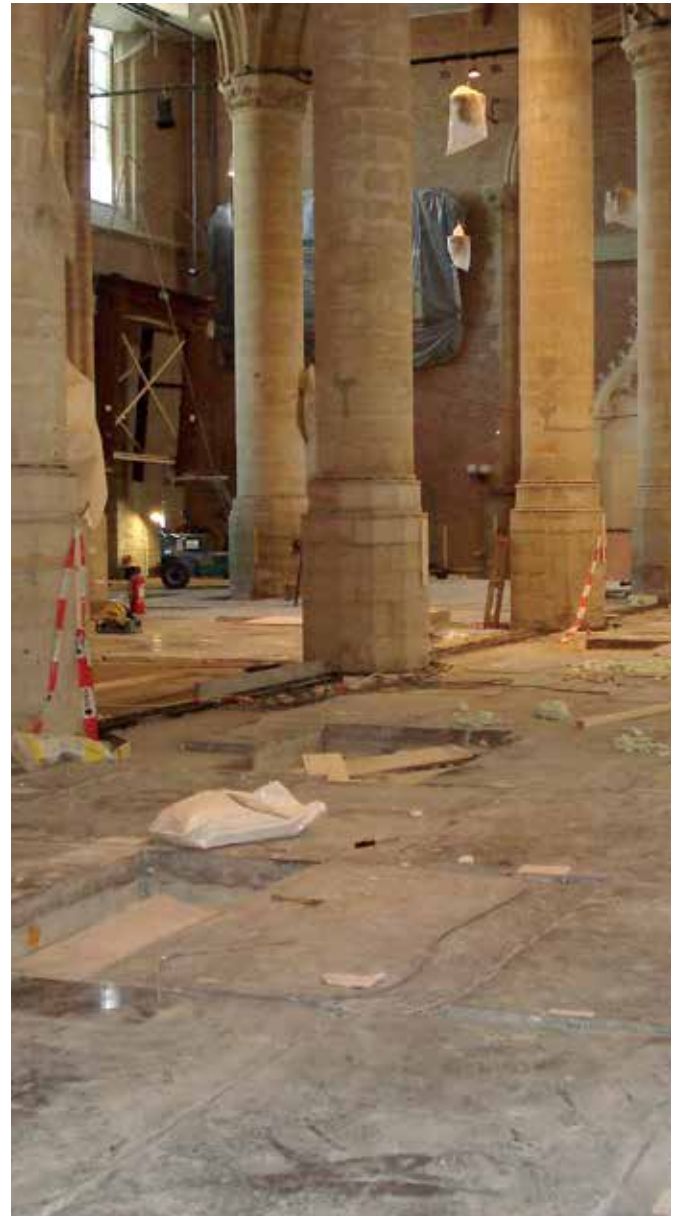
FIG. 6.8 View of the church during the works (Peter's church, Leiden, The Netherlands) / photo: W. Quist

A new circuit of floor heating pipes was introduced in the place of the old one. All gravestones were lifted, taken out and given the same thickness by adding concrete to the backside of the thinner ones [FIG. 6.7, FIG. 6.8]. A limited number of too thick grave stones were not included in the circuit of the floor heating pipes. The pipes run now in a special floor just underneath the gravestone. The result is a faster and less energy consuming heating system.

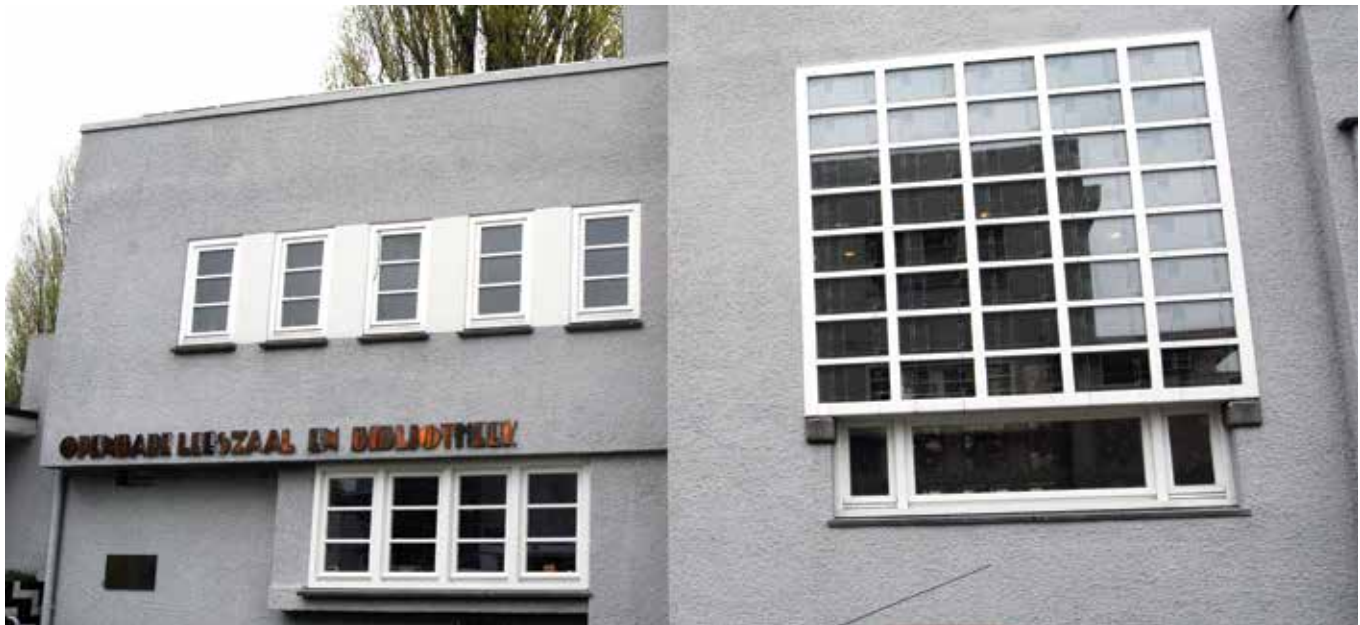
FIG. 6.10 Historic concrete building after restoration (Library, Betondorp, Amsterdam, The Netherlands, arch. D. Greiner) / photo: S. Naldini

Of course there are exceptions. An example, where such an intervention (ETICS) has been applied is the ‘garden suburb’ Watergraafsmeer, better known as *Betondorp* (‘Concrete Village’), in Amsterdam [FIG. 6.9, FIG. 6.10] [Kuipers, 1987, Heinemann, 2013]. *Betondorp* was conceived between 1923 and 1925, on the basis of the designs of eight architects using nine different concrete systems. Some of the systems included a plaster finish. The project had an experimental character: the knowledge on concrete was scarce and many problems arose. Thereby moisture problems were most recurring and severe.

In the restoration of the 1980s it was decided to hinder the ingress of water by means of an external insulation system. The monumental value of the village had at that time been recognized. The intervention was necessary, but needed to be respectful of the appearance of the buildings. It was decided to make use of thermal insulation slabs on which an external plaster would be applied<sup>12</sup>. The new finish of the concrete surface was considered to match the original one. Both energy consumption and comfort could thus be positively influenced, without radically altering the original aspect of the buildings. Such an intervention has a very high impact as it strongly contributes to a prolonged service life of the dwellings and their sustainability. Comfort for the inhabitants was enormously increased.

However, concerning the final aspect of the building, it can be objected that some of the fine contrasting elements in the façade, to which the architectural expression was originally entrusted, are lost, in particular the relationship between protruding and recessed elements, as the layer constituted by insulation and plaster is thicker than the original finishing. Still the solution was found acceptable by Monument care authorities. The intervention in Betondorp can perhaps be considered as an example of a compromise between the historic values of the building to be kept, and the comfort for the modern users to be achieved.

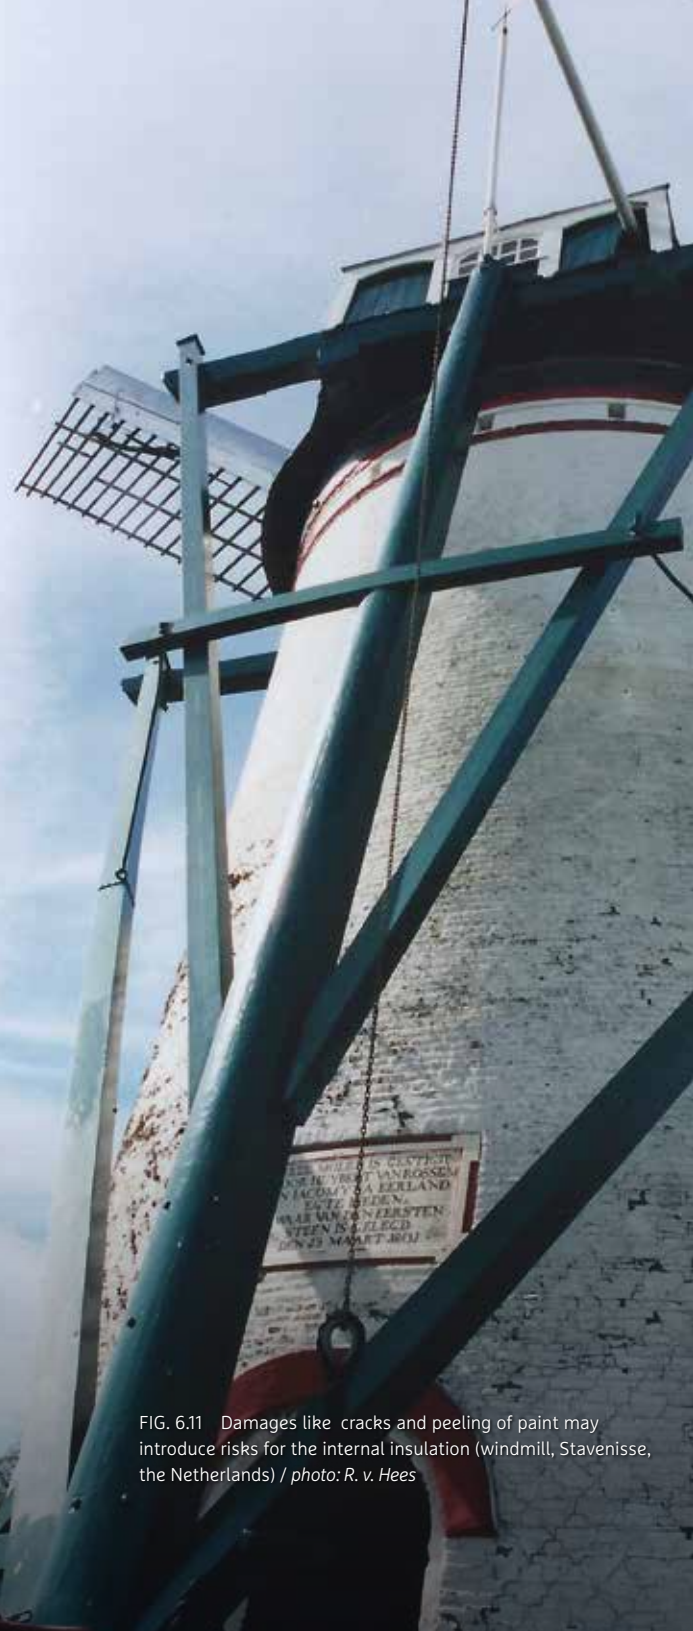
FIG. 6.11 Damages like cracks and peeling of paint may introduce risks for the internal insulation (windmill, Stavénisse, the Netherlands) / photo: R. v. Hees

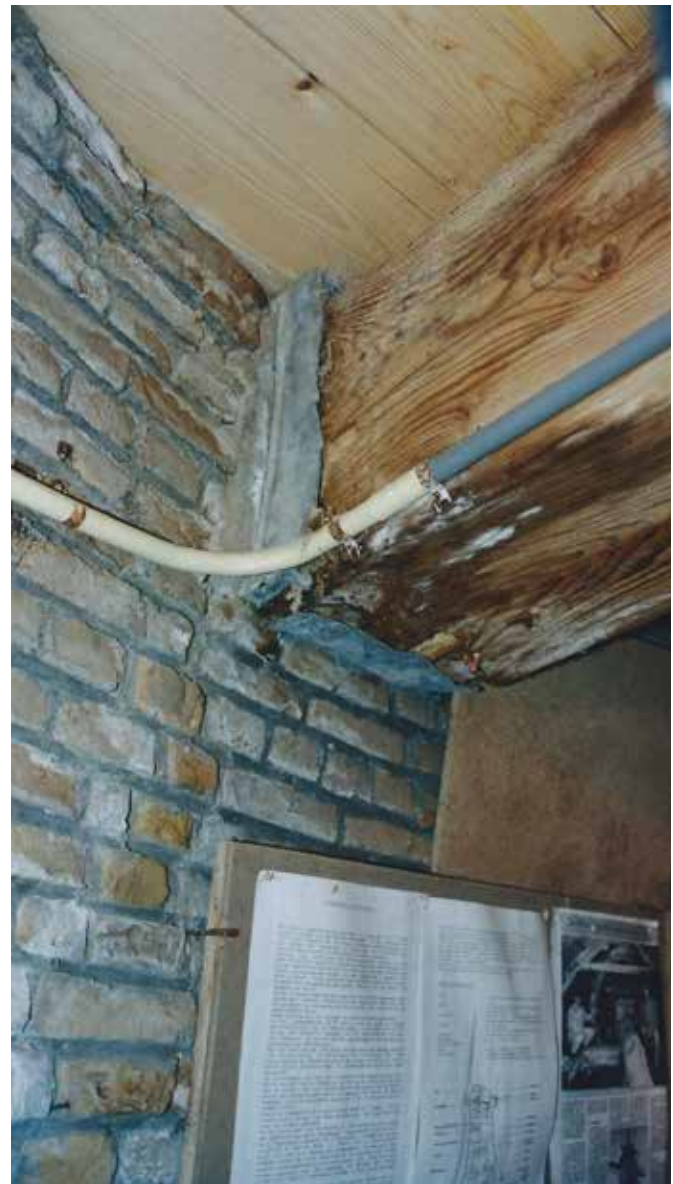
FIG. 6.13 Timber beam in an external wall, showing rot even though it seems well protected by the lead; NB this underlines that drying, which is in this case very difficult, is the most important issue in order to prevent moisture problems from becoming severe (windmill, Stavenisse, the Netherlands) / photo: R. v. Hees

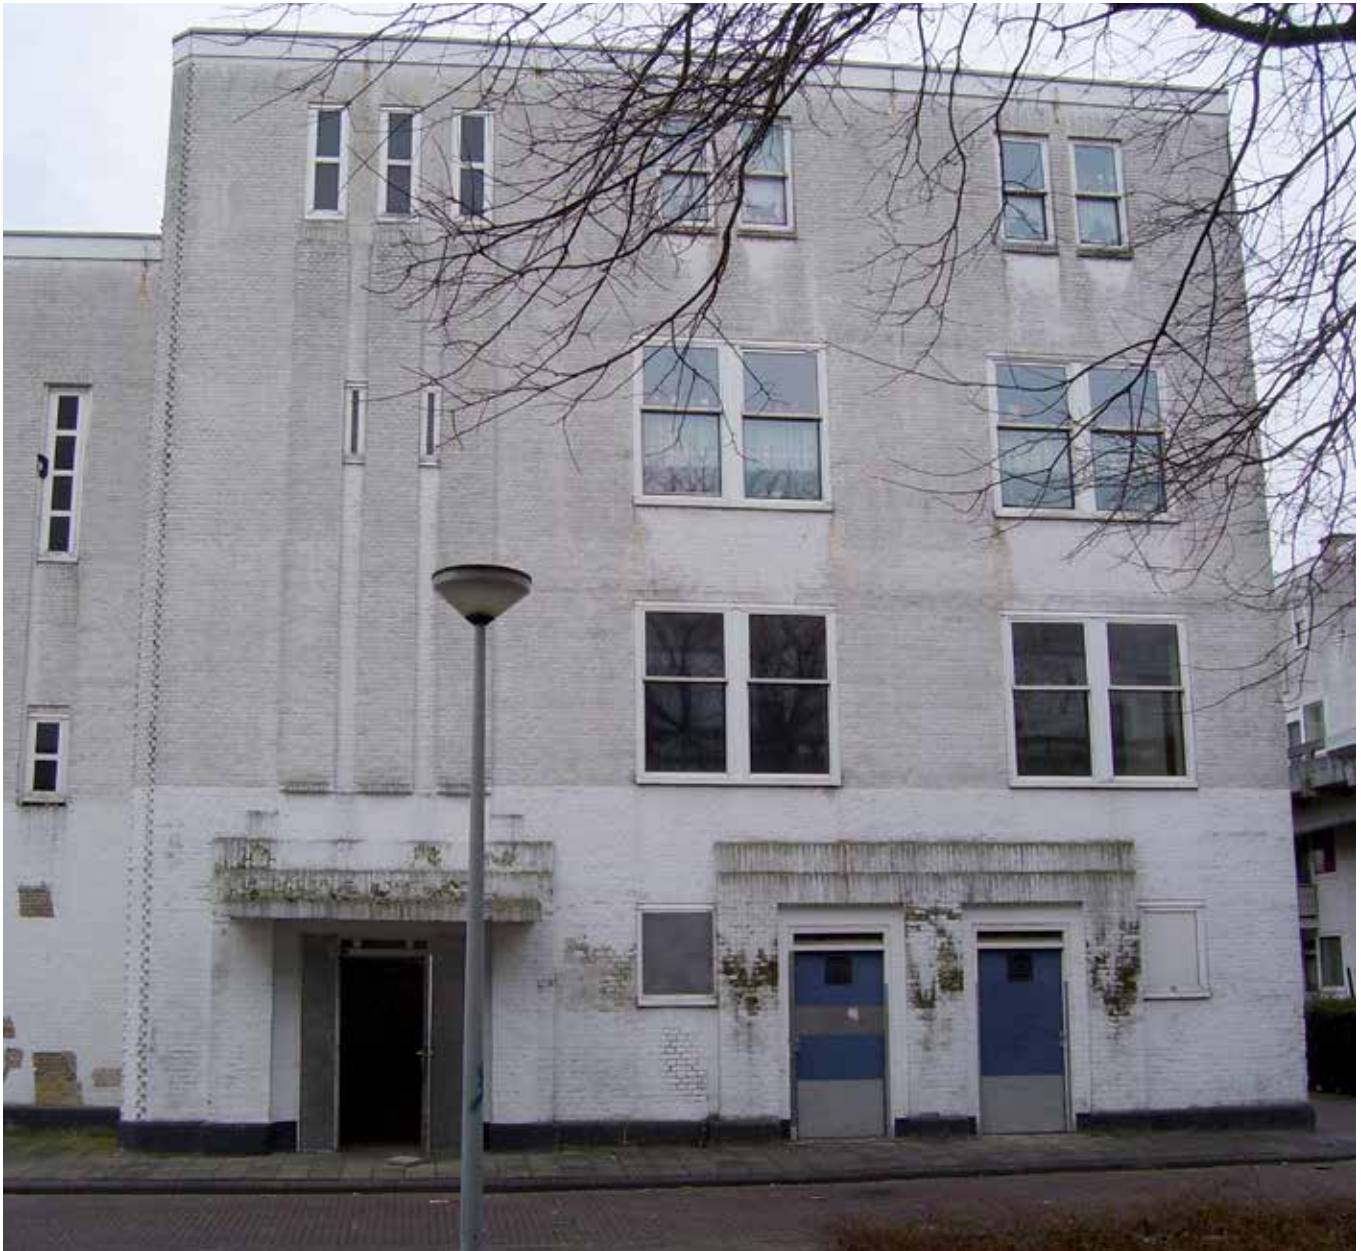
FIG. 6.15 Façade of one building showing damage (2009); to the left: paint removal - try out (Justus van Effen complex, Rotterdam, The Netherlands) / photo: A. Acquebord

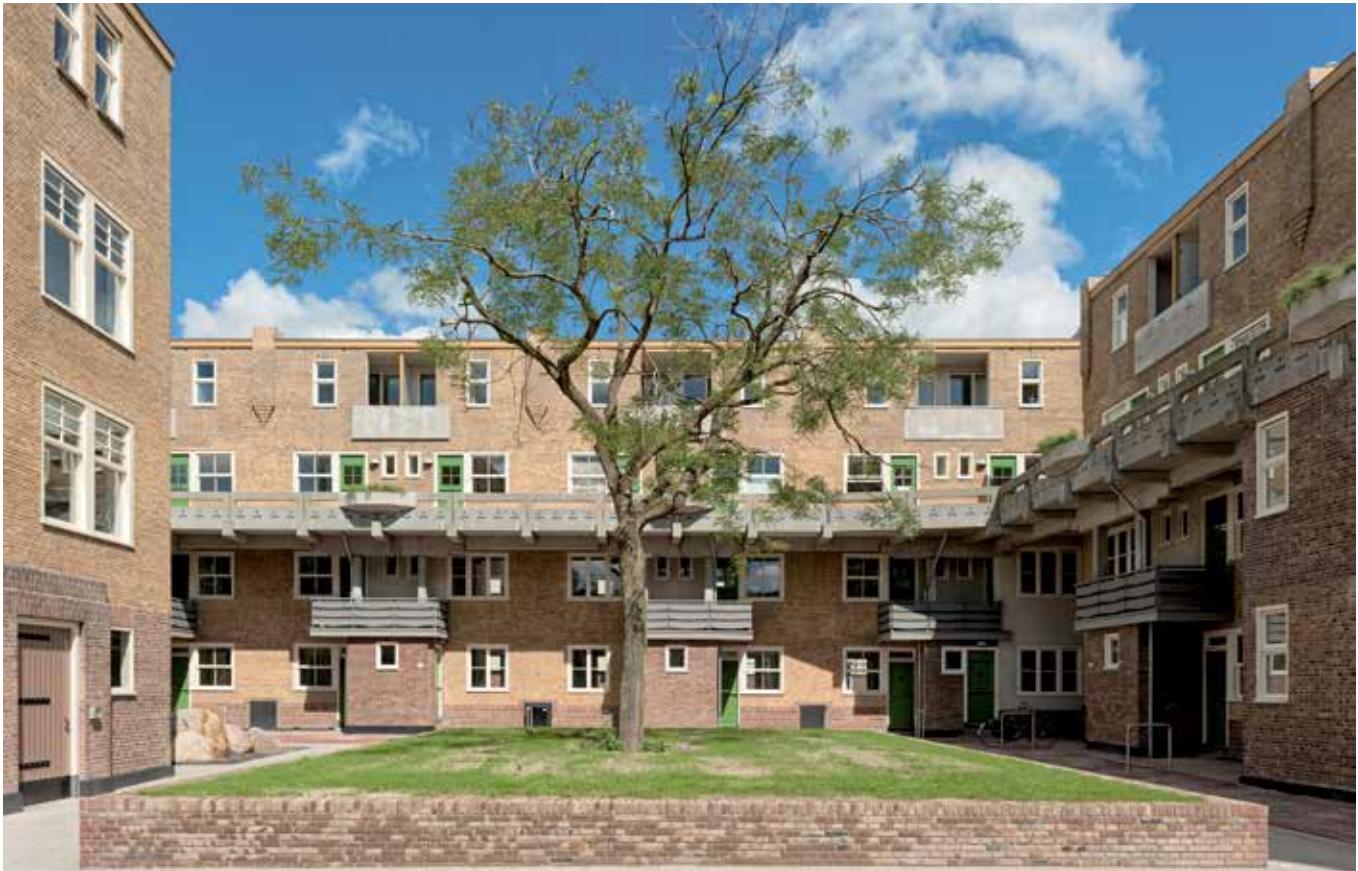
FIG. 6.16 Justus van Effen complex after restoration (Rotterdam, The Netherlands) / photo: BK Visuals Bas van Kooij

The last restoration<sup>13</sup> (2000) was planned to give the building its original value back, and to make it into a pleasant place to live in, within the framework of a sustainable intervention. Under the motto in Dutch ‘100% MO-NU-MENT’ meaning 100% (back to the) original monument and 100% adaptation to modern use, the work was carried out, following a new, integral, philosophy [FIG. 6.16].

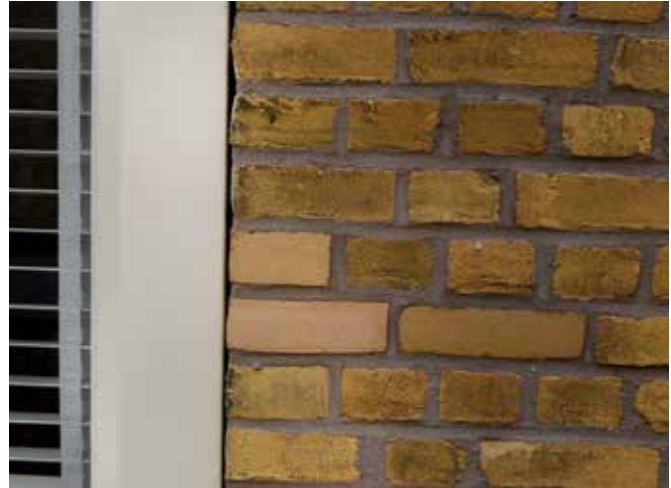
FIG. 6.17 Detail of wall with new bricks (house, Justus van Effen complex, Rotterdam, The Netherlands) / photo: S. Naldini

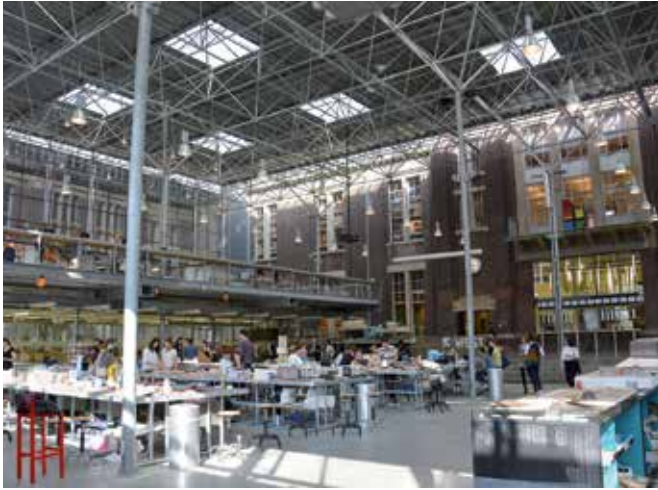
FIG. 6.21 Courtyard transformed into an interior space, interior (Faculty of Architecture, TU Delft, The Netherlands) / photo: S. Naldini

Two external courtyards were transformed into interior spaces using greenhouse elements, and a long corridor, a street indeed with side paths, was designed to connect the various parts of building [FIG. 6.21, FIG. 6.22]. The new building was altered inside to create a clear succession of large rooms meant for educational activities and related functions, and including ateliers, laboratories, conference halls, offices, restaurants and storage rooms: all spaces where the students could work, lessons could be given and visitors accommodated. Besides, long and wide corridors could stimulate contacts between them and the education staff. What is becoming increasingly evident is how successful the definition of the spaces has been: presently there are pleasant spaces where daily life and work concentrate and also attractive spaces to move about, sit, talk.

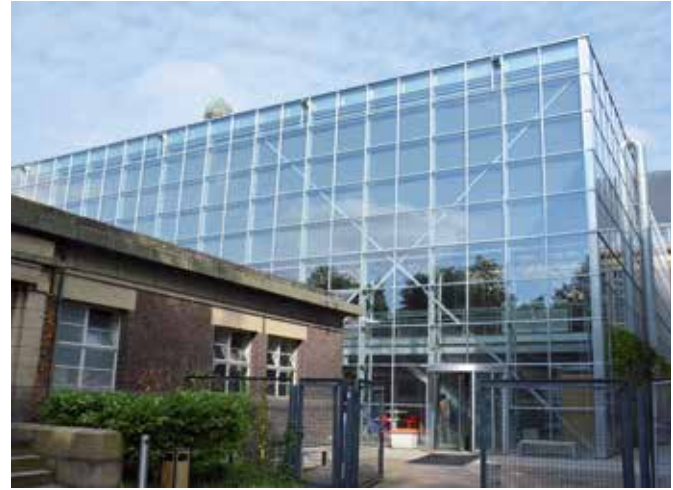
FIG. 6.22 Courtyard transformed into an interior space, exterior (Faculty of Architecture, TU Delft, The Netherlands) / photo: S. Naldini

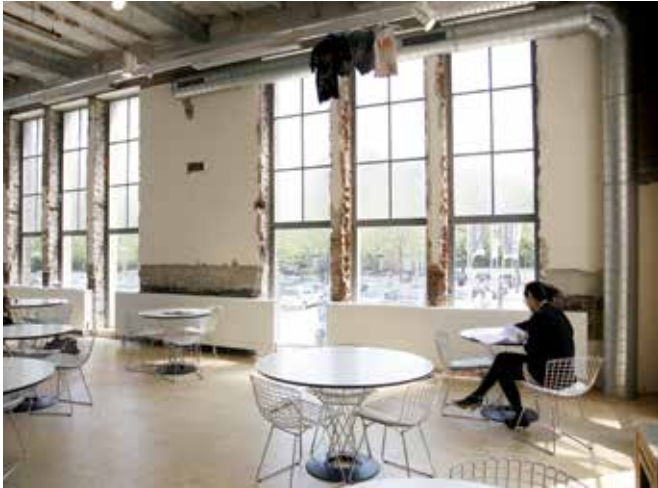
FIG. 6.24 The imperfection of the original construction is left in sight reminding of the function as a laboratory (Faculty of Architecture, TU Delft, The Netherlands) / photo: Braaksmā & Roos

Having taken out all (dropped) ceilings, and having connected the spaces by opening new passages, the building emerged as a strong structure, with exposed materials, pipes and electrical installation, recalling the beauty of the imperfection [FIG. 6.24].

The infrastructure of technical installations left in sight, made the reinterpretation of the original idea of a laboratory emerge in a strong way, in the still informal atmosphere of an unfinished - naked - building.

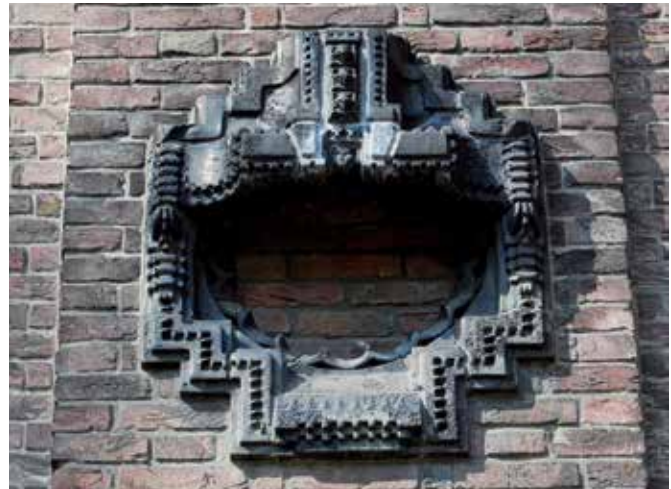
FIG. 6.26 The lion head like ventilation openings (filling visible inside) (Faculty of Architecture, TU Delft, The Netherlands) / photo: S. Naldini

The newly designed system is based on a natural ventilation concept. The starting point for planning the work was again the existing structure. Special attention was paid to the different orientations of the rooms, needing a tailored indoor climate approach, and to the existing ventilation openings, originally meant to serve the rooms where chemical experiments were to be done. These openings, furnished with moulded decorations looking like lion heads [FIG. 6.26], had never been used and were sealed with masonry fillings.

The new plan of natural ventilation is based on the most effective and still less intrusive measures possible: the 'lion heads' were freed from the filling and re-used and ventilation ducts were hung from the ceiling.

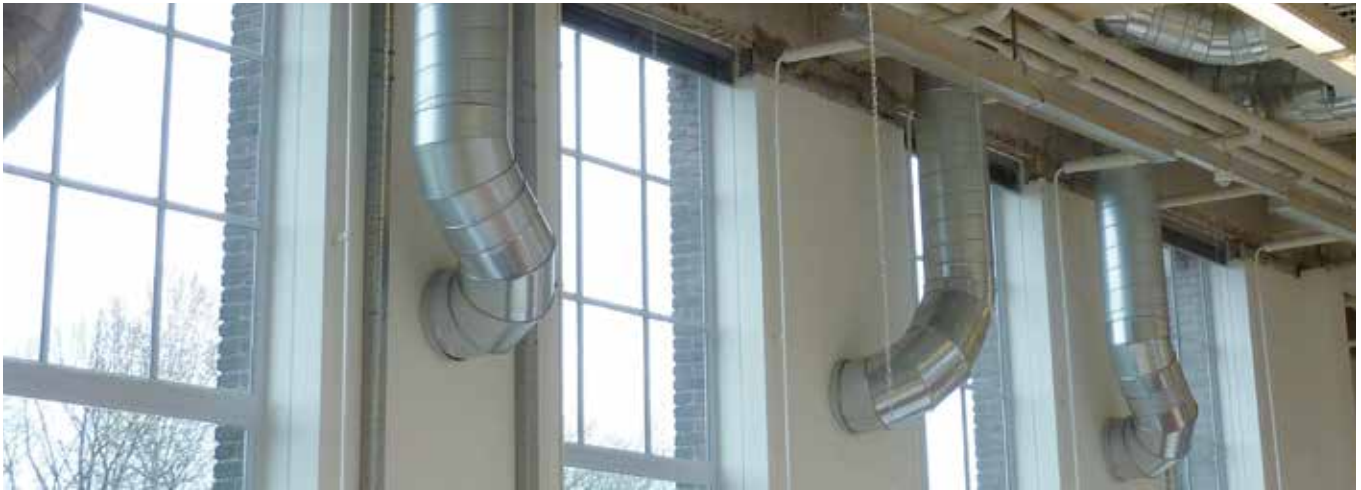
The exhaust air flows near the supply duct, thus heating up the fresh air. On the left a textile duct is visible, which swells when air is supplied. Through little holes the air is distributed in the room. The duct on the right used to serve as air supply duct in the ventilation system of 2008.

FIG. 6.27 Ventilation ducts connected with the 'lion heads' (Faculty of Architecture, TU Delft, The Netherlands) / photo: S. Jansen

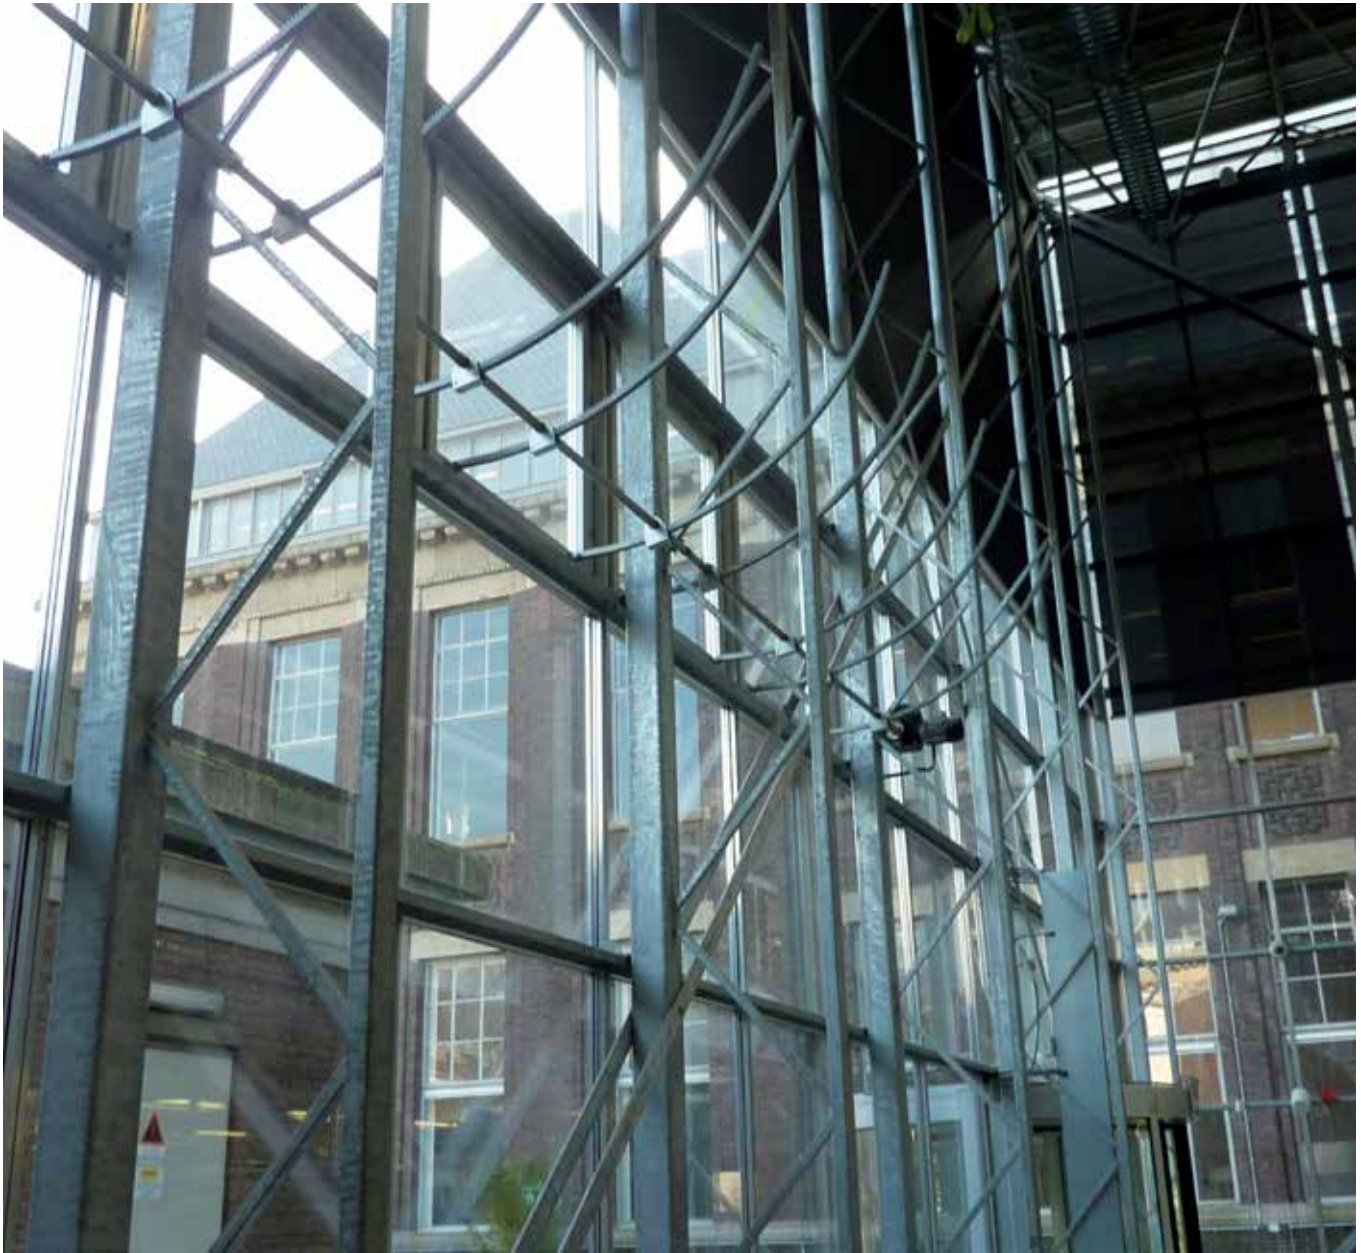
FIG. 6.28 Supply (fabric) and exhaust ducts (Faculty of Architecture, TU Delft, The Netherlands) / photo: S. Jansen

In FIG. 6.28, supply and exhaust ducts can be seen.

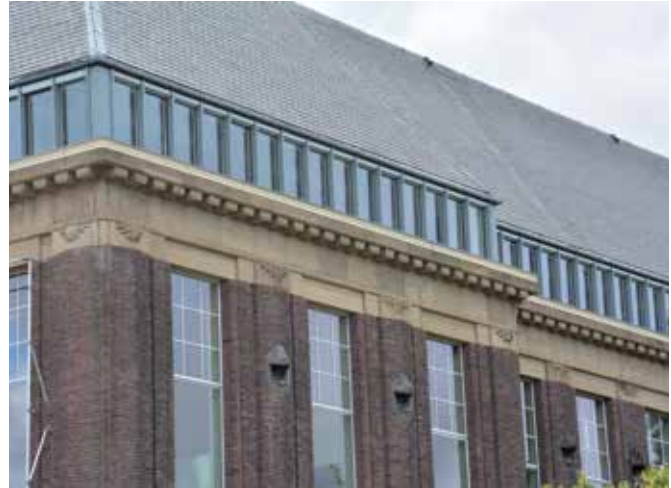
FIG. 6.31 Present situation of roof and windows; the frames are now aluminum (Faculty of Architecture, TU Delft, The Netherlands) / photo: S.Naldini

The general maintenance of the building will also include the brick masonry, natural stone and the slates of the roofs. The roof will be given special attention. The roof originally reaching the string-course of the façade had been transformed already in the 1960's, before the re-use, in such a way that windows could be placed, to make the attic space utilizable. In 2008 these windows were found to be in a pretty bad state

of conservation and were upholstered and painted in bright colours, those of the European flags. In this way the more informal atmosphere of the new faculty would be expressed by the exterior of the building and the international character of the faculty suggested. However, this solution was meant to be temporary, and a recently started intervention will substitute the windows with aluminium framed ones. The informal colouring as an expression of an 'in between' time is no longer valid. A neutral expressive and repetitive way of placing windows more belonging to the roof than to the façade, is the solution chosen, as an interpretation of the old slate roof ending on the stone cornice [FIG. 6.30, FIG. 6.31].

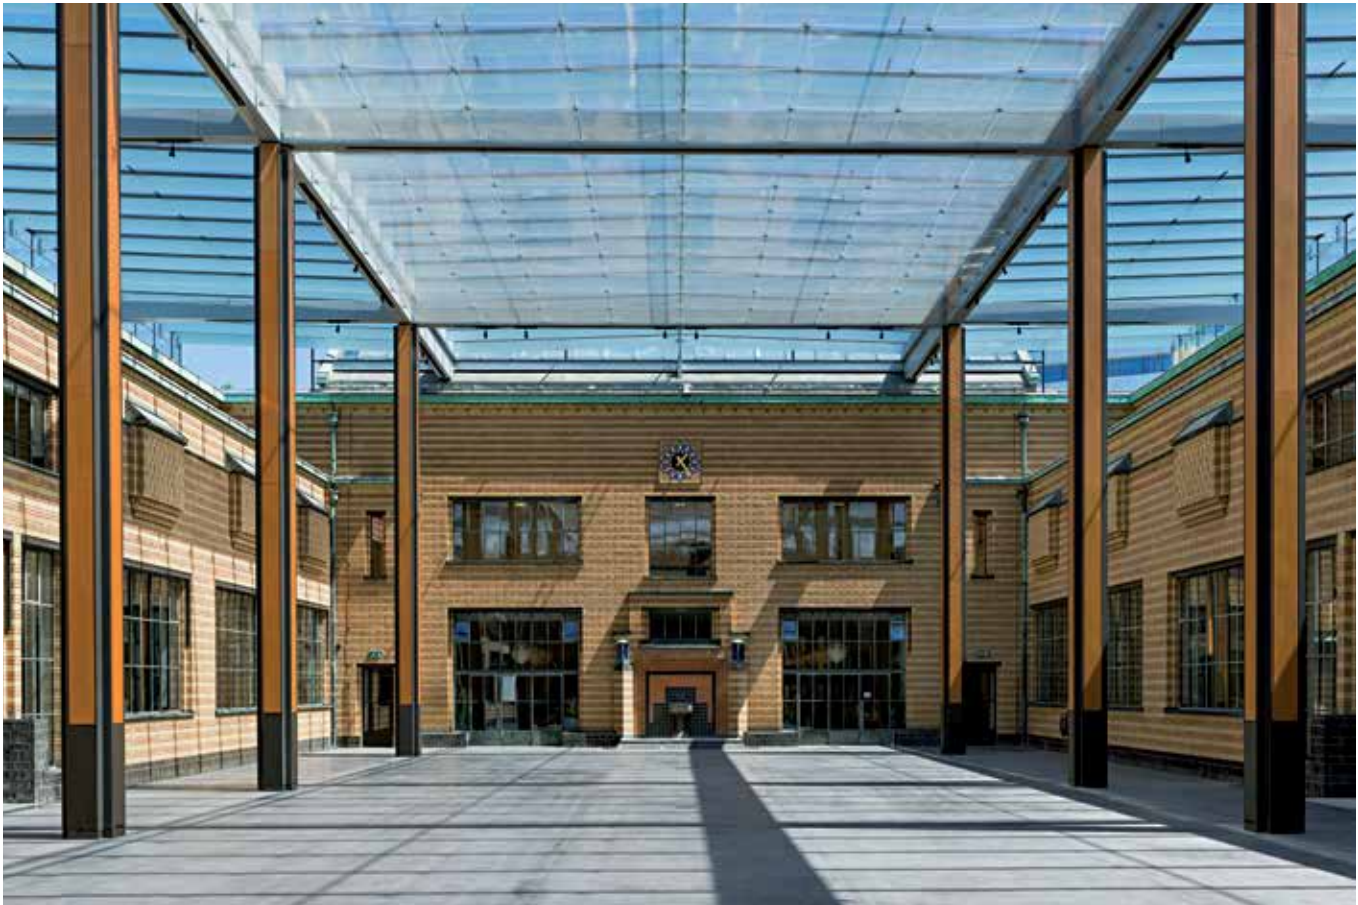
FIG. 6.33 The new construction in dialogue with the architecture of H.P. Berlage (Gemeentemuseum, The Hague, The Netherlands, arch. Braaksma & Roos) / photo: A. Veldt

Very important was to find out how to make the outdoor space interior, without losing its character as an outdoor room and besides making the new construction dialogue with the architecture of H.P. Berlage. The intervention was meant to create architecture of great durability and sustainability showing very precise craftsmanship and love and care for materials and details, as expressed by the treatment of the 'skin' of his buildings. It was in fact decided to use Berlage's work as a starting point, focussing on his architectural style, a hybrid reminding of Italian Renaissance and the architecture of Frank Lloyd Wright, and the role assigned to colour and pattern of the brick masonry. The beautiful light falling in the museum from the windows overlooking the garden was definitely to be maintained. In order to leave the atmosphere undisturbed, a construction completely made of glass was designed, different from that of BK city where a more 'industrial' atmosphere had been created. [FIG. 6.33]

In both cases an independent structure was engineered apart from the existing buildings. In the museum, the glass roof would be supported by eight metal and clad columns, leaving the construction of the museum completely untouched, and giving the impression of being floating over the existing museum-building. Rainwater from the roof would be collected in invisible gutters.
