# Durable past – sustainable future

Rob van Hees  
Silvia Naldini  
Job Roos

TU Delft OPEN  
Publishing

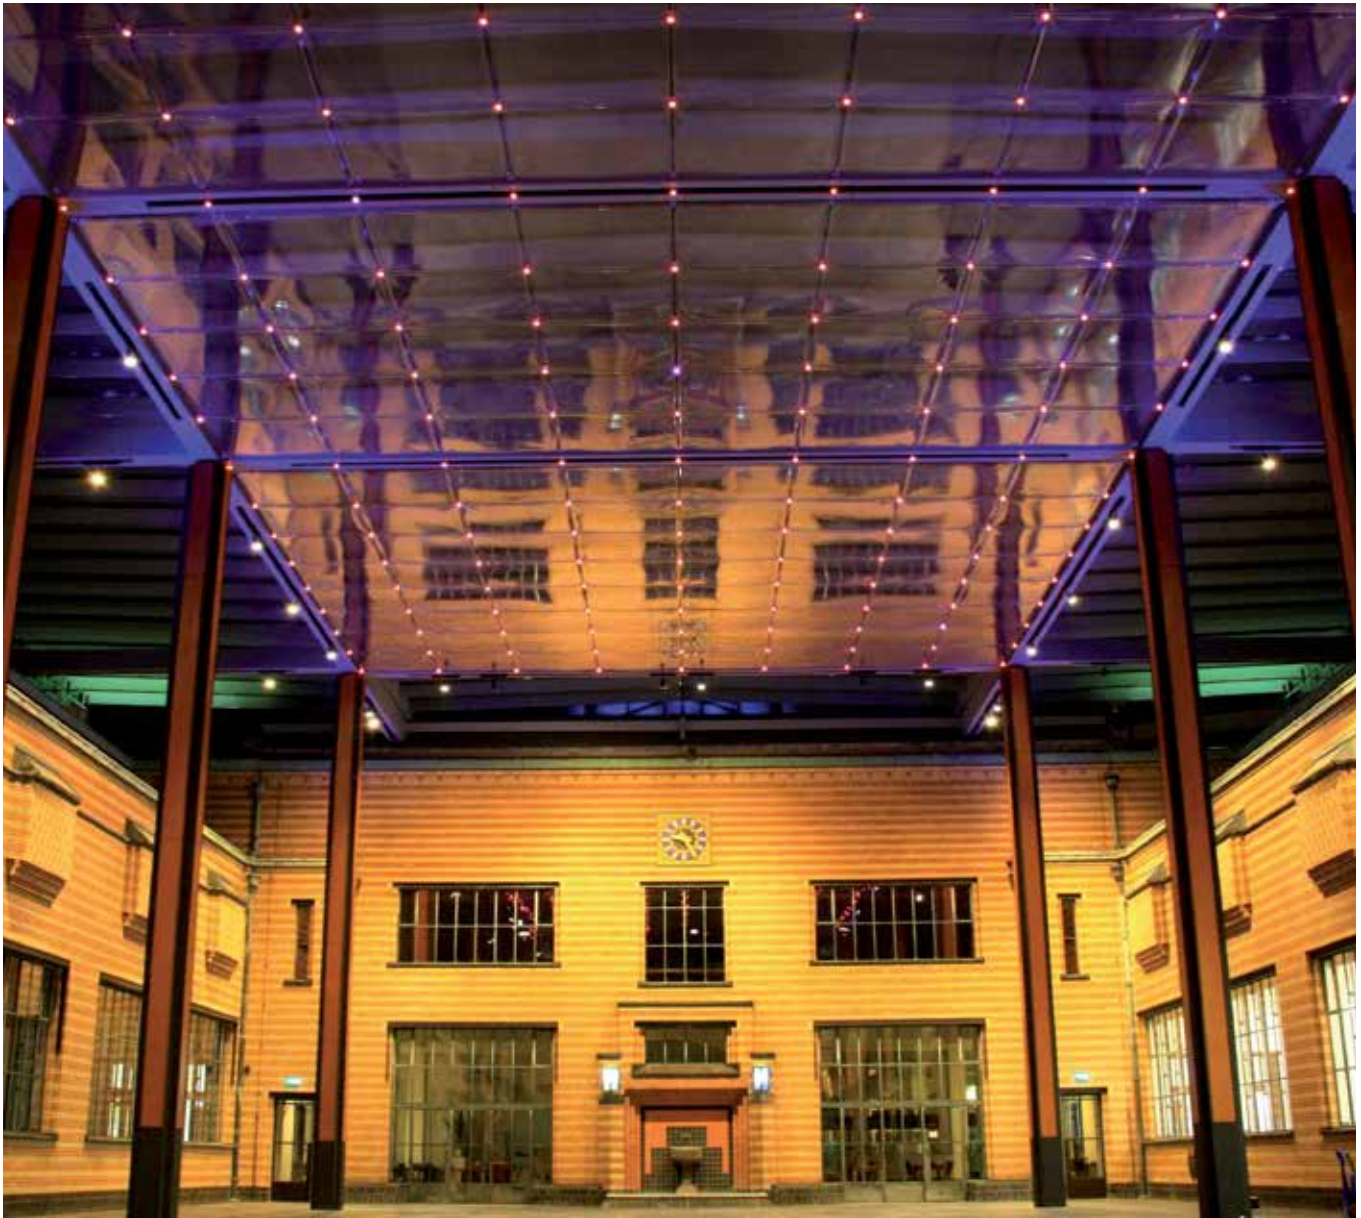
FIG. 6.35 Night view of former garden (Gemeentemuseum, The Hague, The Netherlands, arch. Braaksm & Roos) / bron: <http://www.livingdaylights.nl/project/gemeentemuseum> / photo: Proliad

The columns support a grid of iron beams covered with insulated glass panes. All glass elements are fastened securely. All columns and beams are clad with perforated aluminium (behind which installations/wires are hidden), which helps to comply with acoustic standards. Under the glass, an additional transparent layer contributing to the acoustic performance of the space has been inserted [FIG. 6.35].

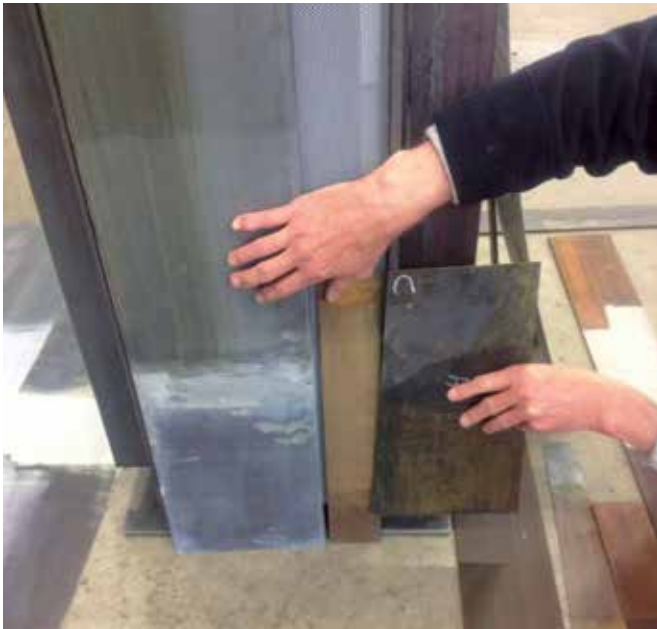
FIG. 6.36 Craftsmanship: materials made according to traditional methods and selected for their properties and also colour (Gemeentemuseum, The Hague, The Netherlands) / photo: Braaksm & Roos

The floor was made in dark brownish-grey concrete to match the plinths of the original walls (thin copper expansion grooves have been made in the floor) and to enhance the light colour of the brick masonry. All construction elements have been fabricated and applied by high-level craftsmen, possessing good knowledge of the materials and their use [FIG. 6.36]. This was an innovative approach allowing to make the dialogue with Berlage - always so interested in all aspects of the materialization - very explicit and to have the existing and the new merge.

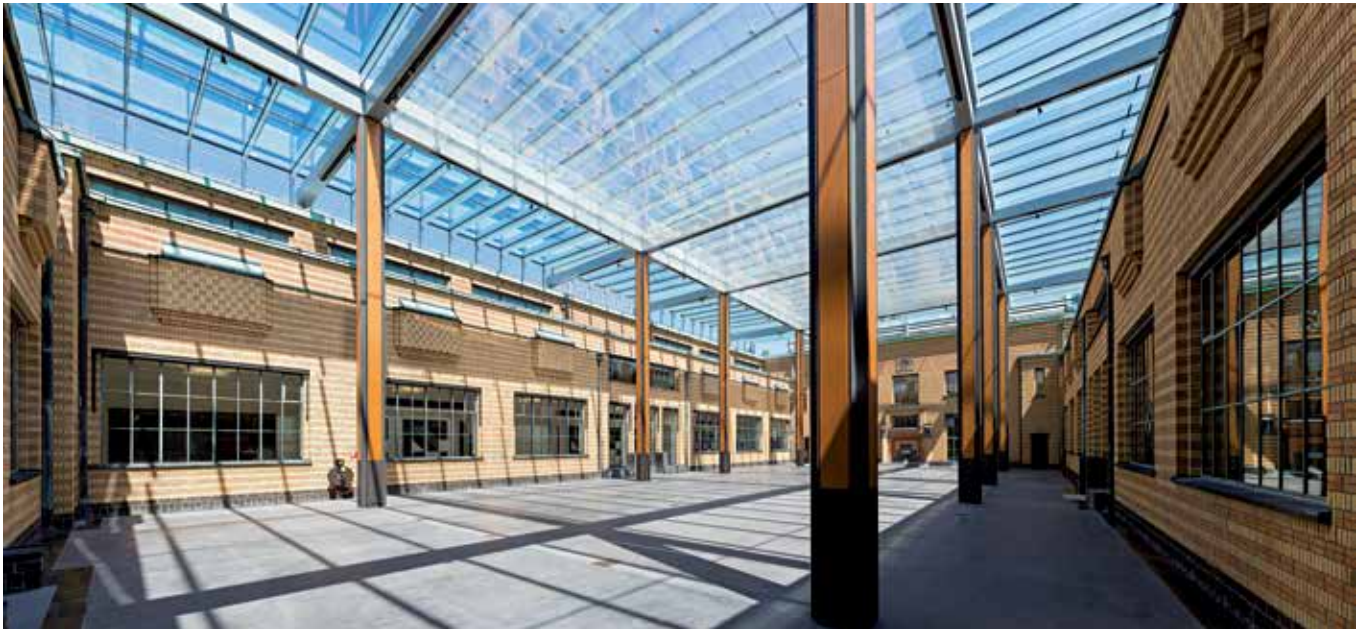
FIG. 6.38 The glass structure floating on the existing walls in the transformed garden (Gemeentemuseum, The Hague, The Netherlands, arch. Braaksmas & Roos) / photo: A. Veldt

The glass construction is thus in line with Berlage's building, in terms of form and colours, does not hinder the ingress of light in the museum, and, although open and transparent, is thermally and acoustically insulated [FIG. 6.38]. In this sense the most essential heritage values of the building have been respected and even underlined by the detailing and the choice of materials of the intervention, whereas functional elements for the sustainable use, such as acoustic materials and thermal insulating glass have been applied. The materials used are products of good craftsmanship and have been coated, painted and applied in such a way as not to undergo deterioration processes. In this sense they are also durable. The new enclosed space can be defined as being sustainable.

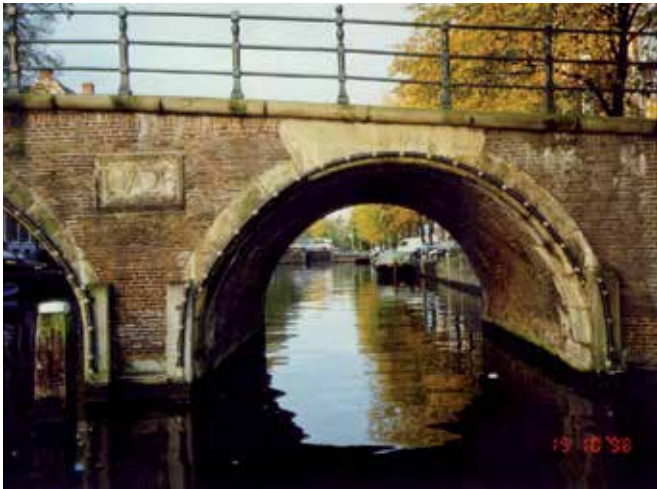
FIG. 7.2 Self-healing in lime mortar (canal bridge in Amsterdam, The Netherlands) / photo: R. v. Hees

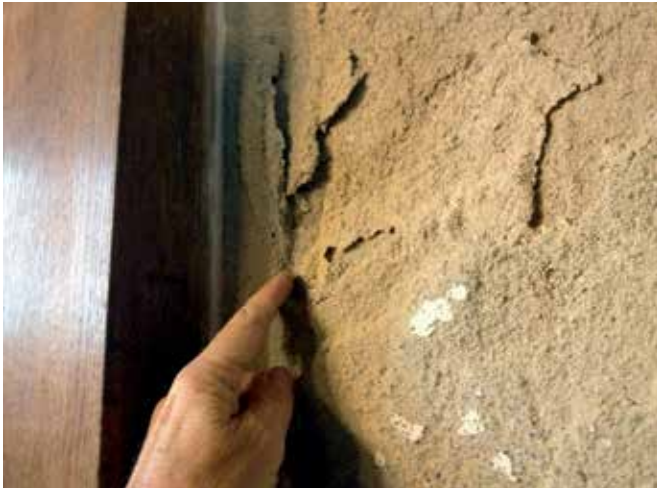
FIG. 7.4 Exfoliation and crumbling of plaster applied on a salt loaded substrate / photo: R. v. Hees

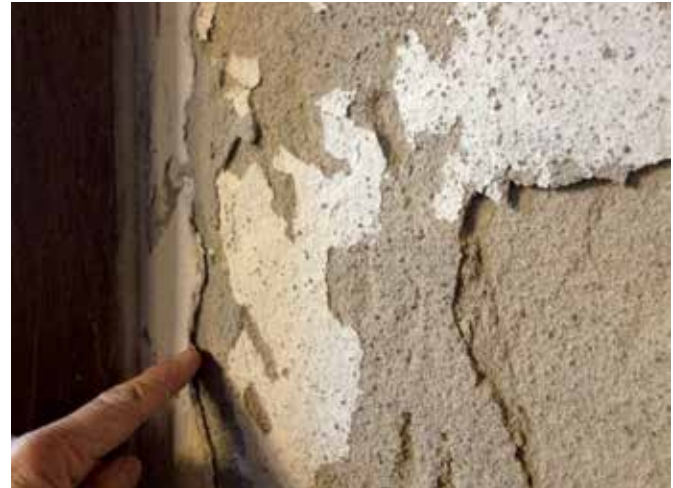
FIG. 7.5 Loss of adhesion and crumbling of plaster applied on a salt loaded substrate / photo: R. v. Hees

What is new now is the idea that such a process could perhaps be controlled and enhanced or optimized and could eventually be applied to hinder other degradation processes. At the Faculty of Architecture in Delft in 2013 a PhD research project was started to investigate the possibilities of self-healing of repair mortars for restoration purposes [Granneman, 2013]. One of the most recurrent degradation processes taking place in ancient materials (stone, brick, mortar) is salt crystallization resulting in different damage types like crumbling or sanding of the materials [FIG. 7.4, FIG. 7.5].

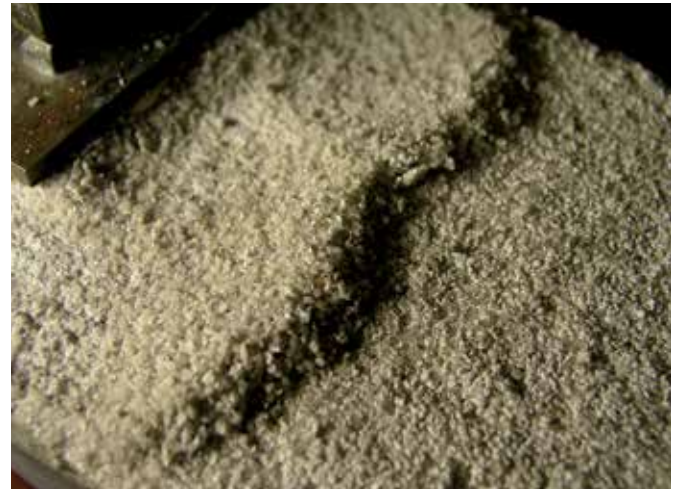
FIG. 7.7 Sanding of the outer layer of the mortar in the presence of NaCl after 6 RH cycles / photo: s Barbara Lubelli

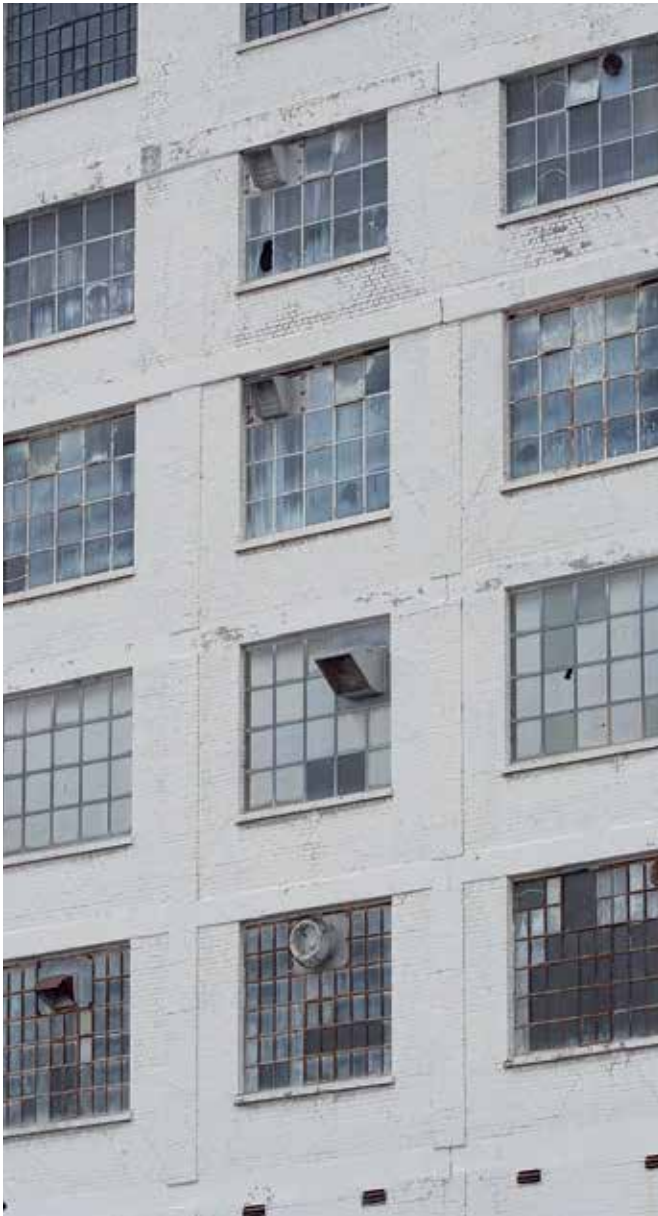
FIG. 7.13 The sequence of windows is an important aesthetic factor as they animate the façade (Sphinx factory, Maastricht, The Netherlands) / photo: Braaksma & Roos

Many are the precious elements forming this unique building and needing preservation. The concrete slabs, often irregular in structure and bearing the signs of the formwork, and the imperfection of the steel window-frames and grids, so far away from the present idea of sustainability in terms of modern requirements, but still important to create relief in the long wall surfaces [FIG. 7.13] belong to the essential elements determining the perception of the building and revealing its character. The re-use of the building requires well-considered solutions, in equilibrium between the preservation and enhancement of the value of the existing construction and the wanted flexibility to meet the needs of different potential users, guaranteeing a durable exploitation and easy management and maintenance. Such a far-reaching goal has to be achieved with very limited interventions and the minimum economic effort possible. A feasible approach was planned for each problem to be solved, without applying a priori solutions, but always trying to be innovative within an established ethical and technical framework. A preliminary, deep-going study (building archaeology, materials and technical state of conservation) was done to better understand the building in all its aspects, from its volumes and internal connections of the various parts, to the materials and techniques used. Having assessed the state of conservation of all the components, and their value, compatible materials and suitable techniques were selected for the interventions.
